NOWRA 2021

Using State Revolving Fund (SRF) grants
for Failing Onsite Remediation in
Arkansas and Missouri

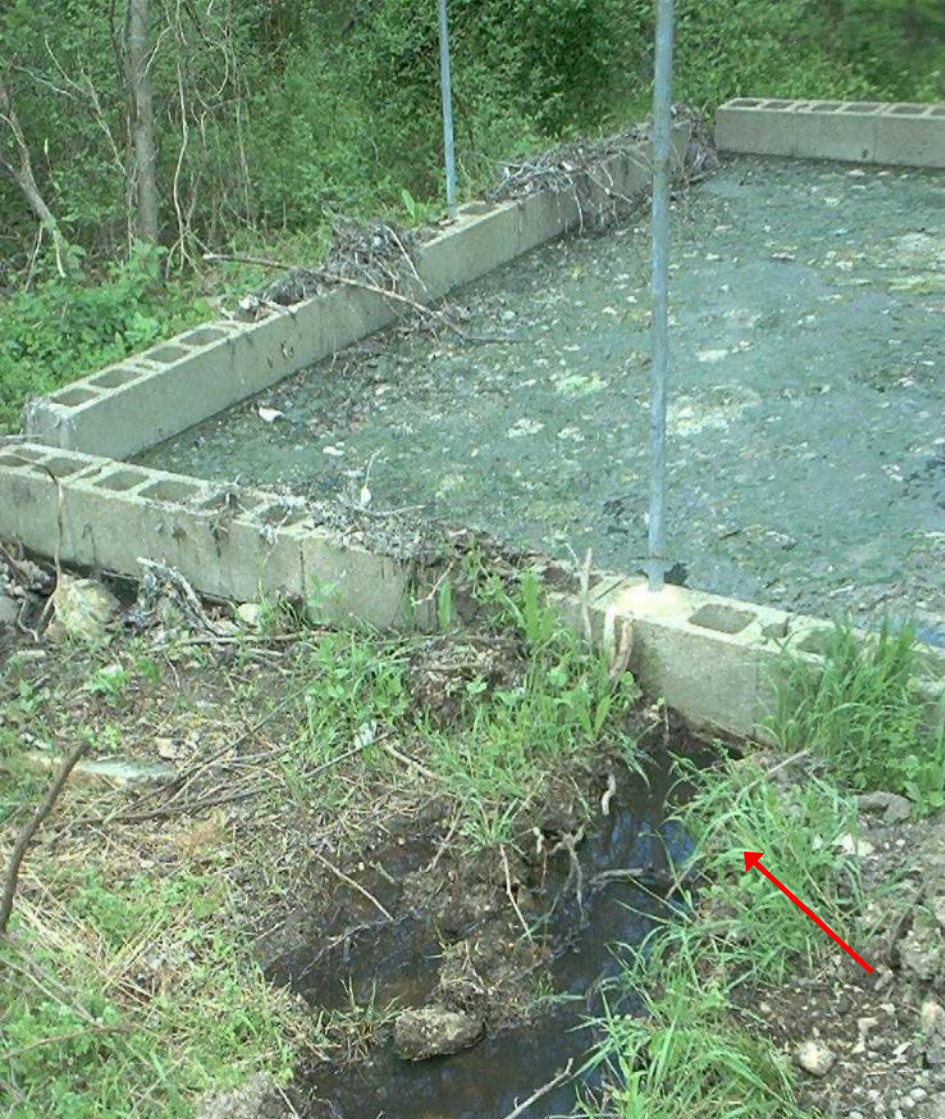
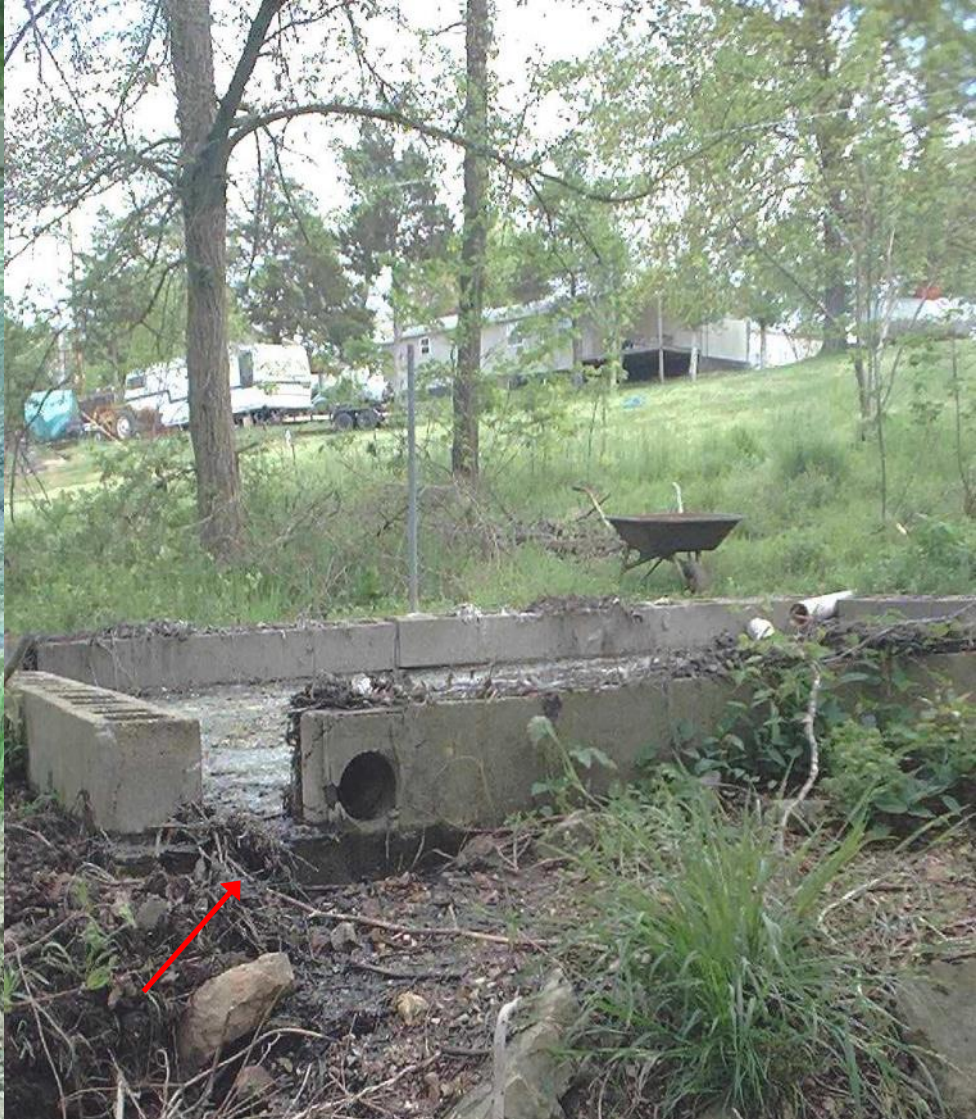
Single cell lagoon serving a resort on Table Rock Lake manager's residence and three adjoining rentals. White pipe in upper right of photo is inflow pipe, smaller pipe at lower center is discharge pipe that leads through lagoon berm.

Single cell lagoon serving a small restaurant, restrooms, and owner's home.

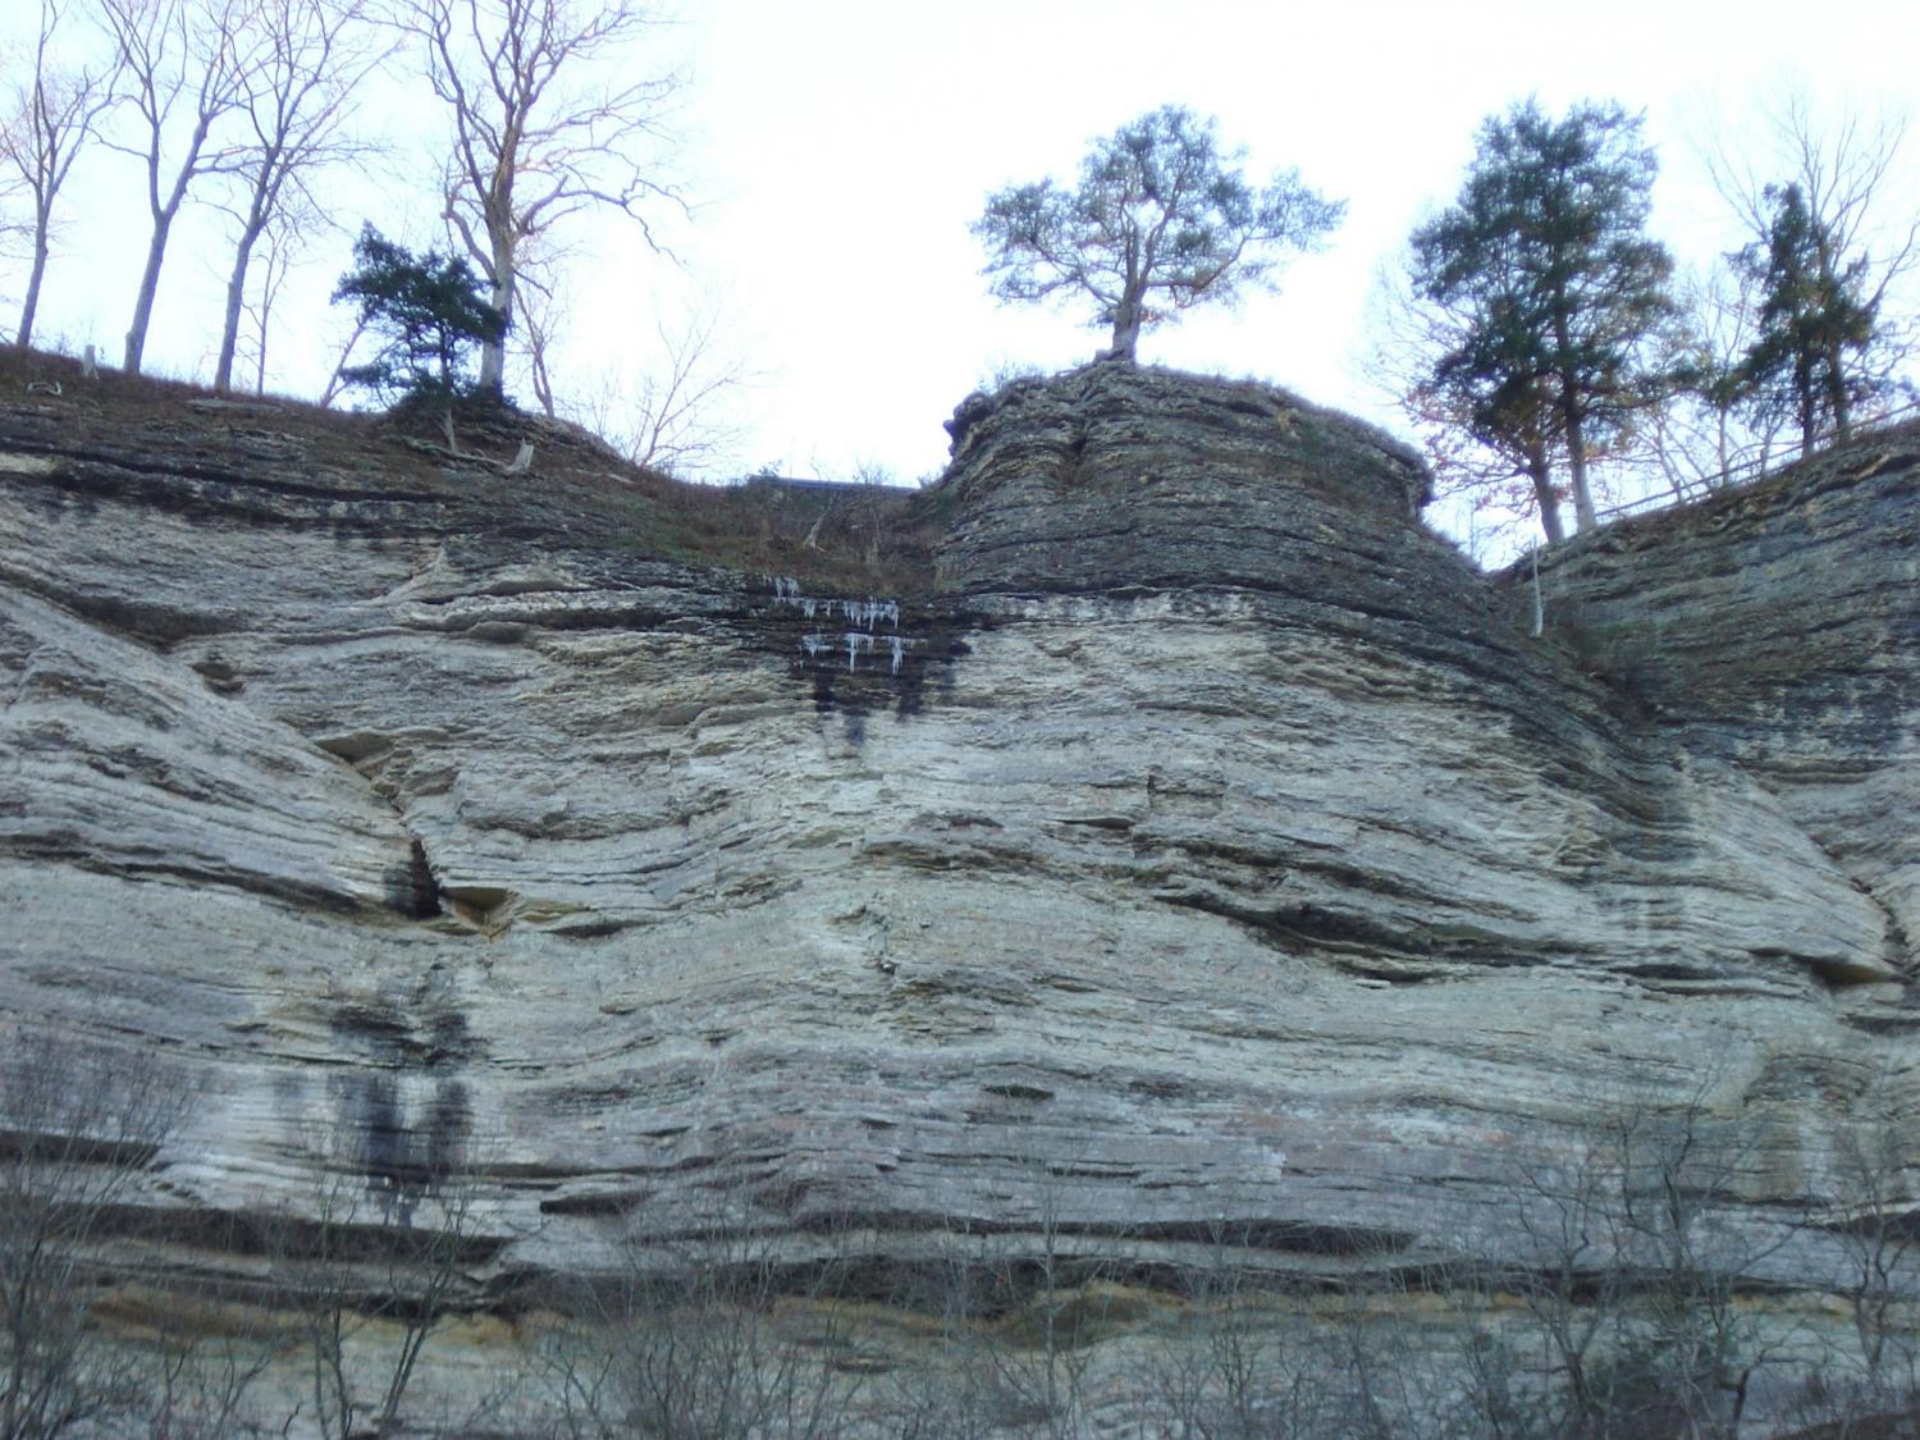
Lagoon serving restaurant leaking through southwest side of wall at left, and block removed allowing discharge at right.

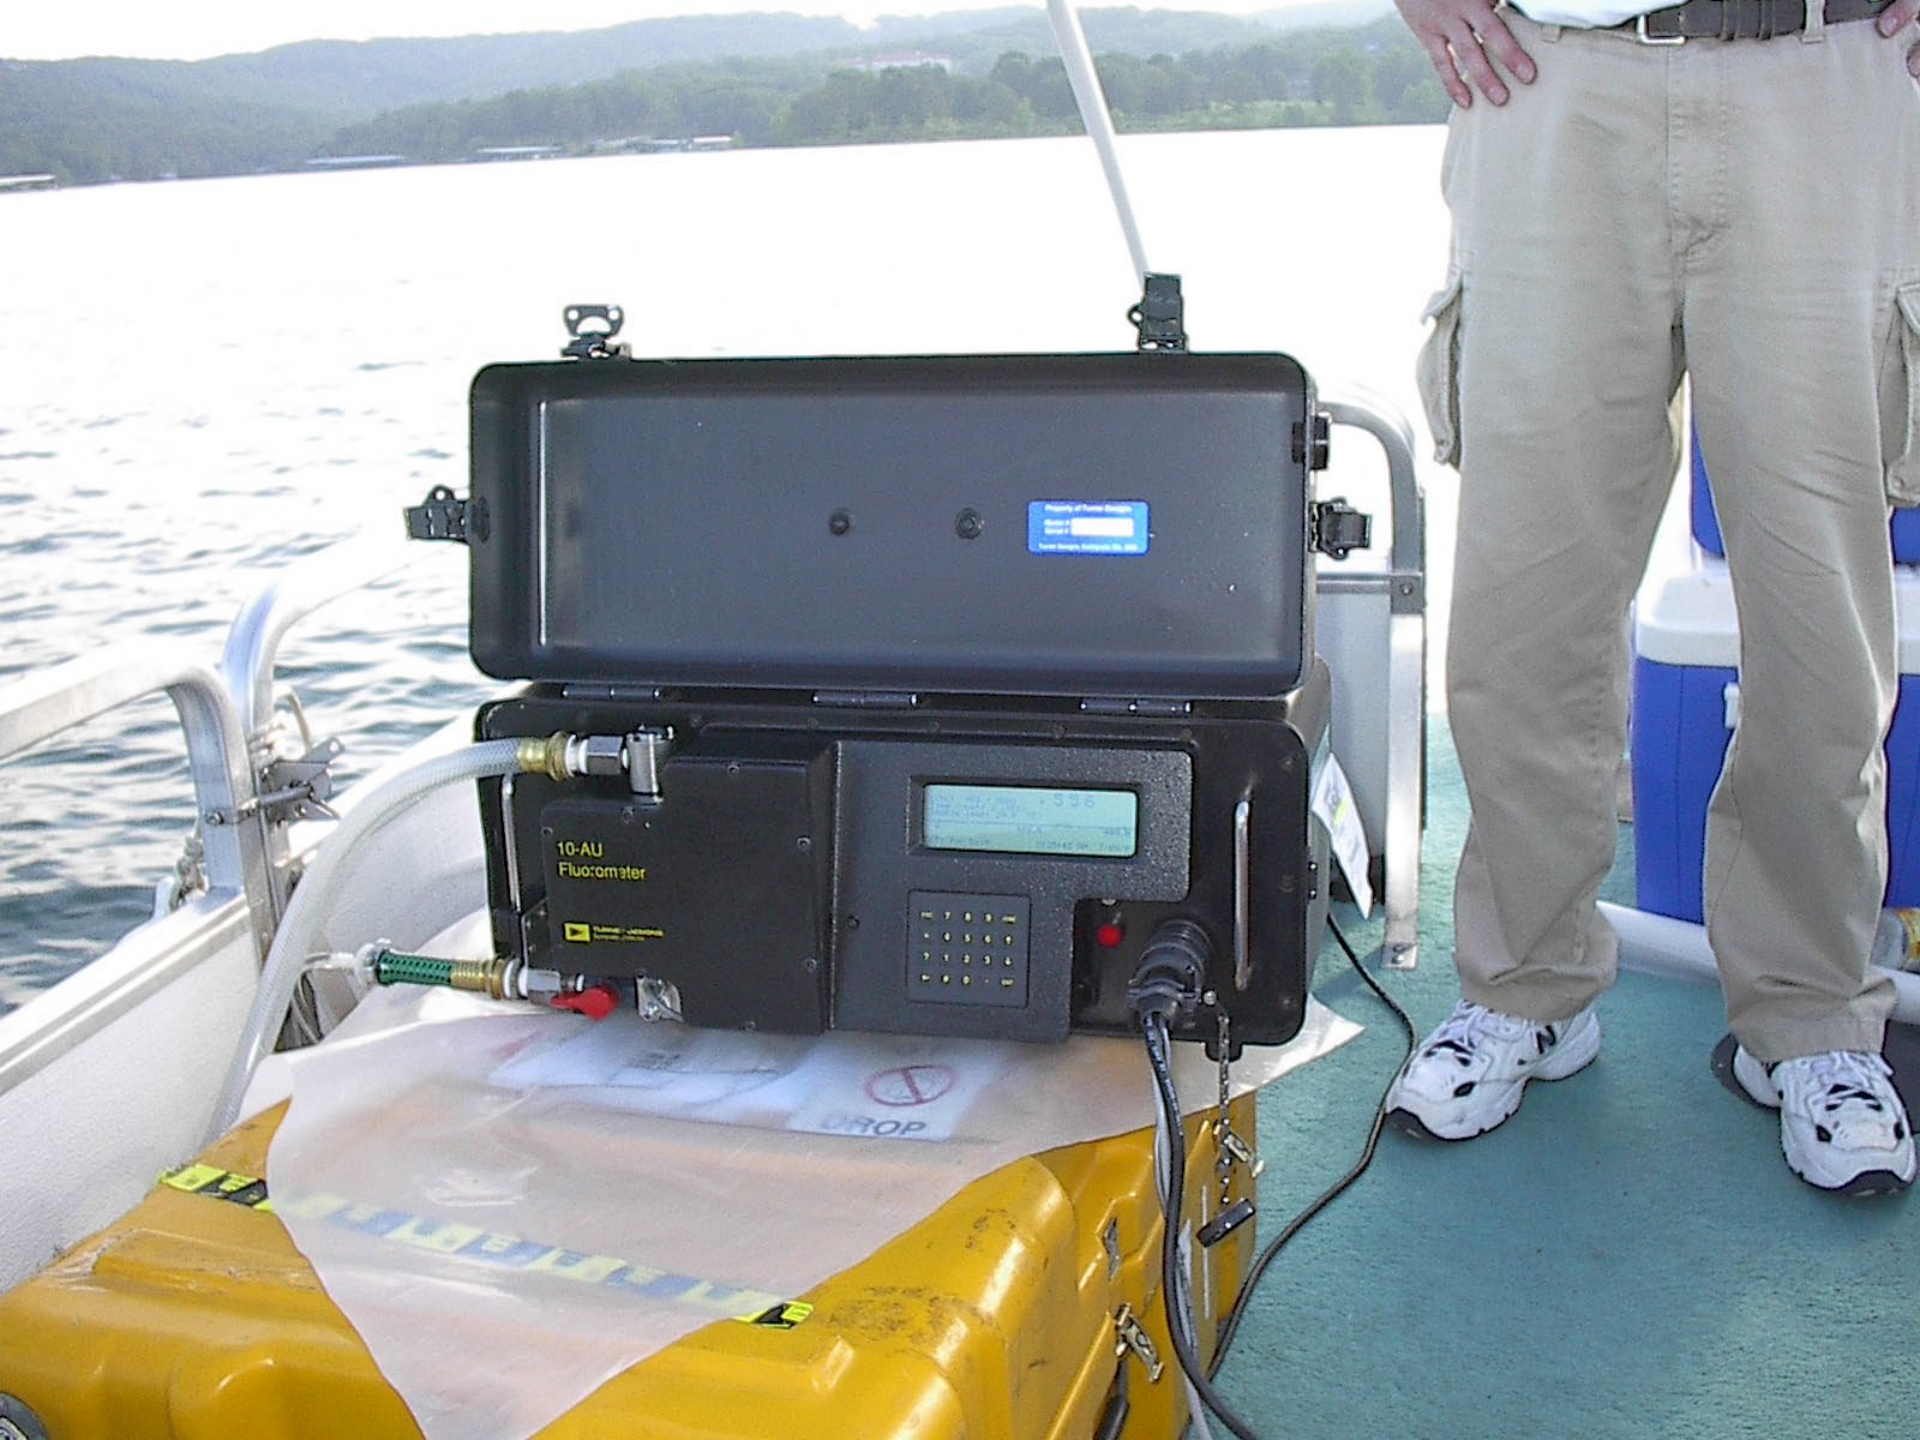
Figure 6: Sampling Arrangement and Septic System Effluent Fate and Transport

- ① Septic Tank
- ② Lateral Drain Field
- ③ Septic System Effluent
- ④ Effluent Mixing By Wave-Induced Currents
- ⑤ Probe
- ⑥ Pump
- ⑦ Fluorometer

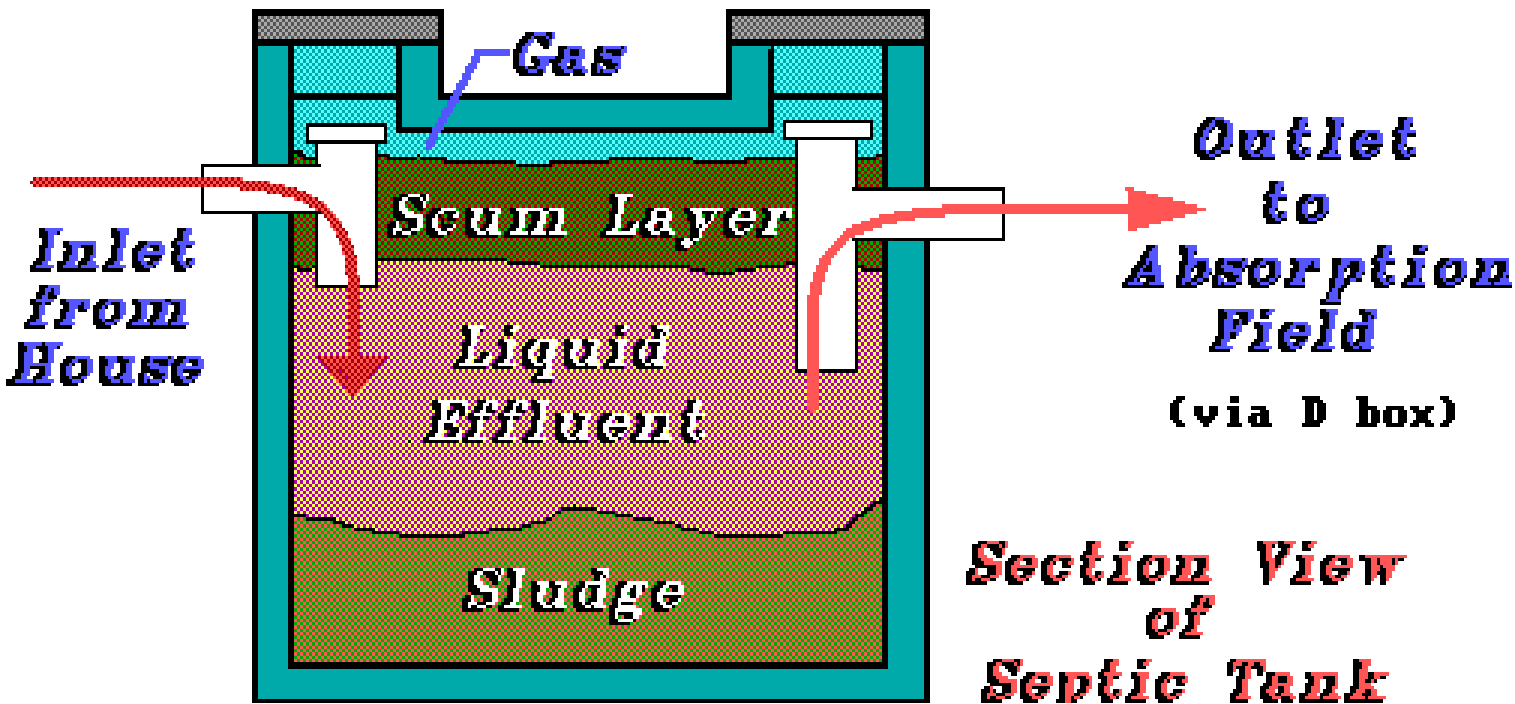
**Section View
of
Septic Tank**

The solids that settle to the bottom of the septic tank slowly decompose. Gas bubbles given off during this process rise, carrying with them, fats, oils, and greases. The tank outlet is located between these two layers where the clearest liquid is found. Tanks typically should be pumped every 3 years to prevent sludge and scum from clogging the leaching field. Actual pumpout schedules should be based on frequent tank inspections.

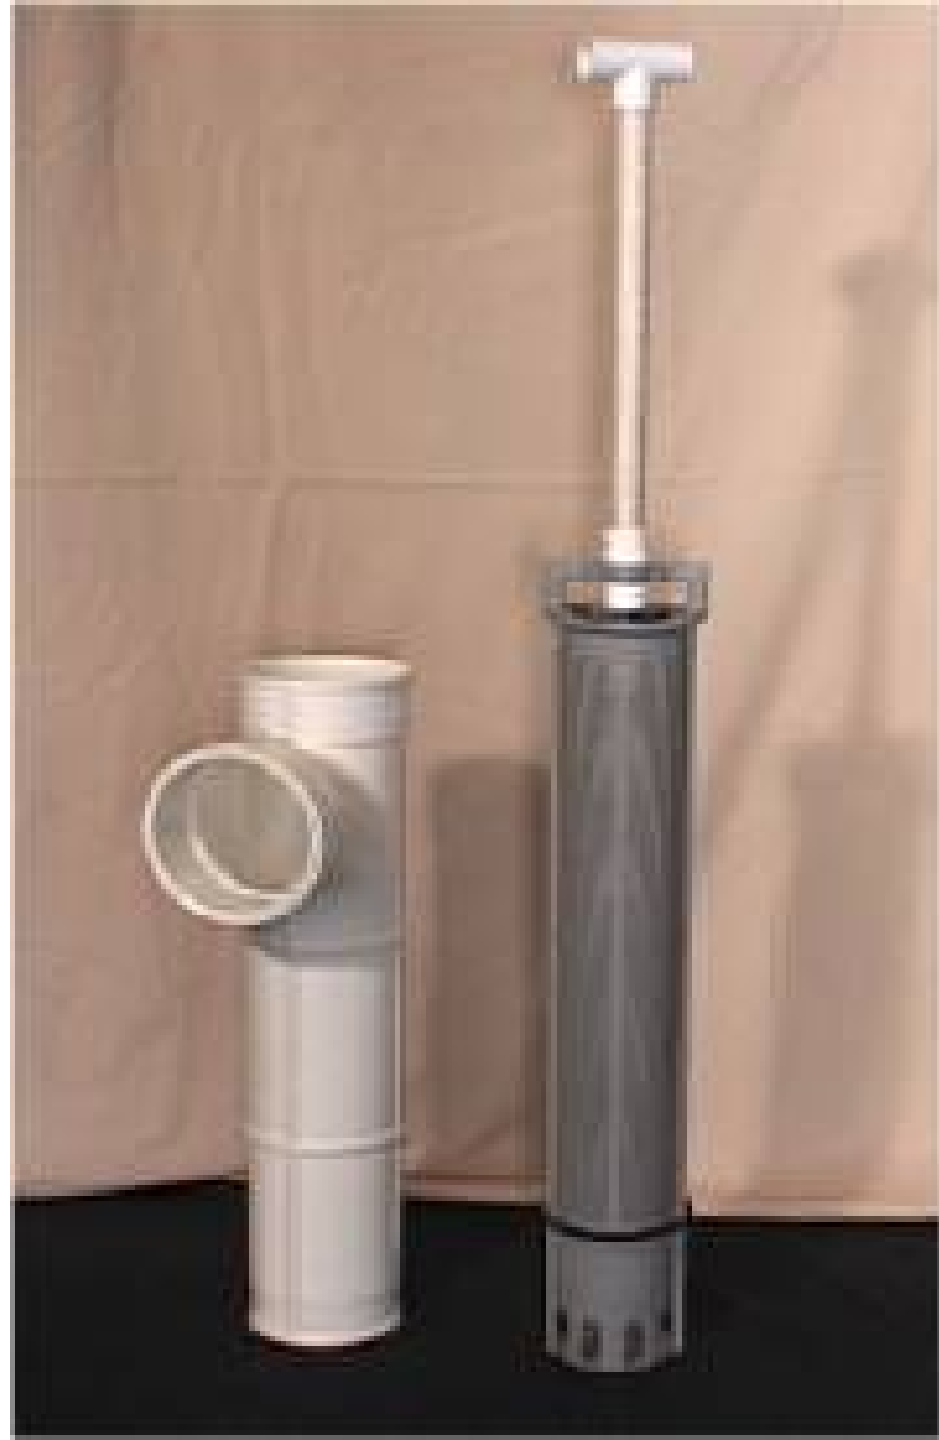
Effluent filter

- Keeps solids out of the leach field
- Requires maintenance
- Clogged filter will cause a backup of sewage into the home

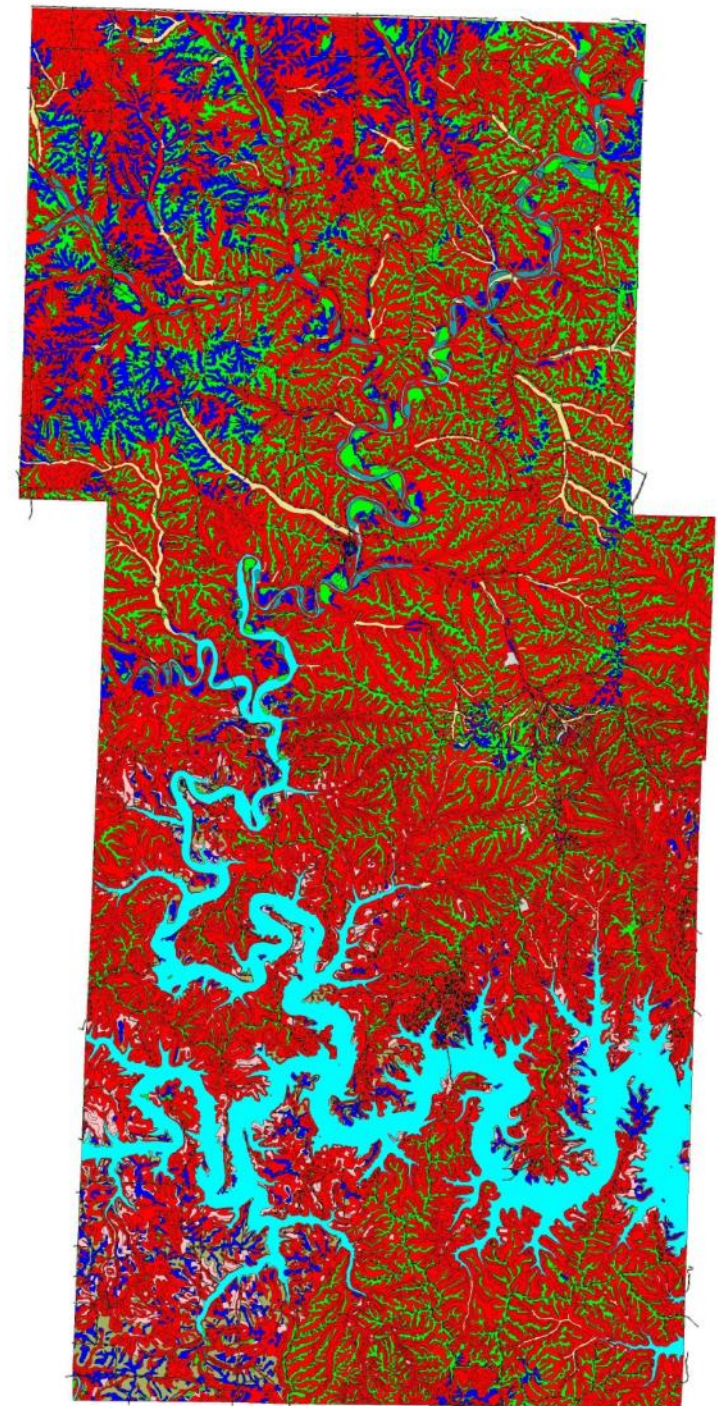
Stone County
Septic Absorption Field

RED is “Very Limited”
This means a conventional septic systems has a very little chance of working in these soil conditions

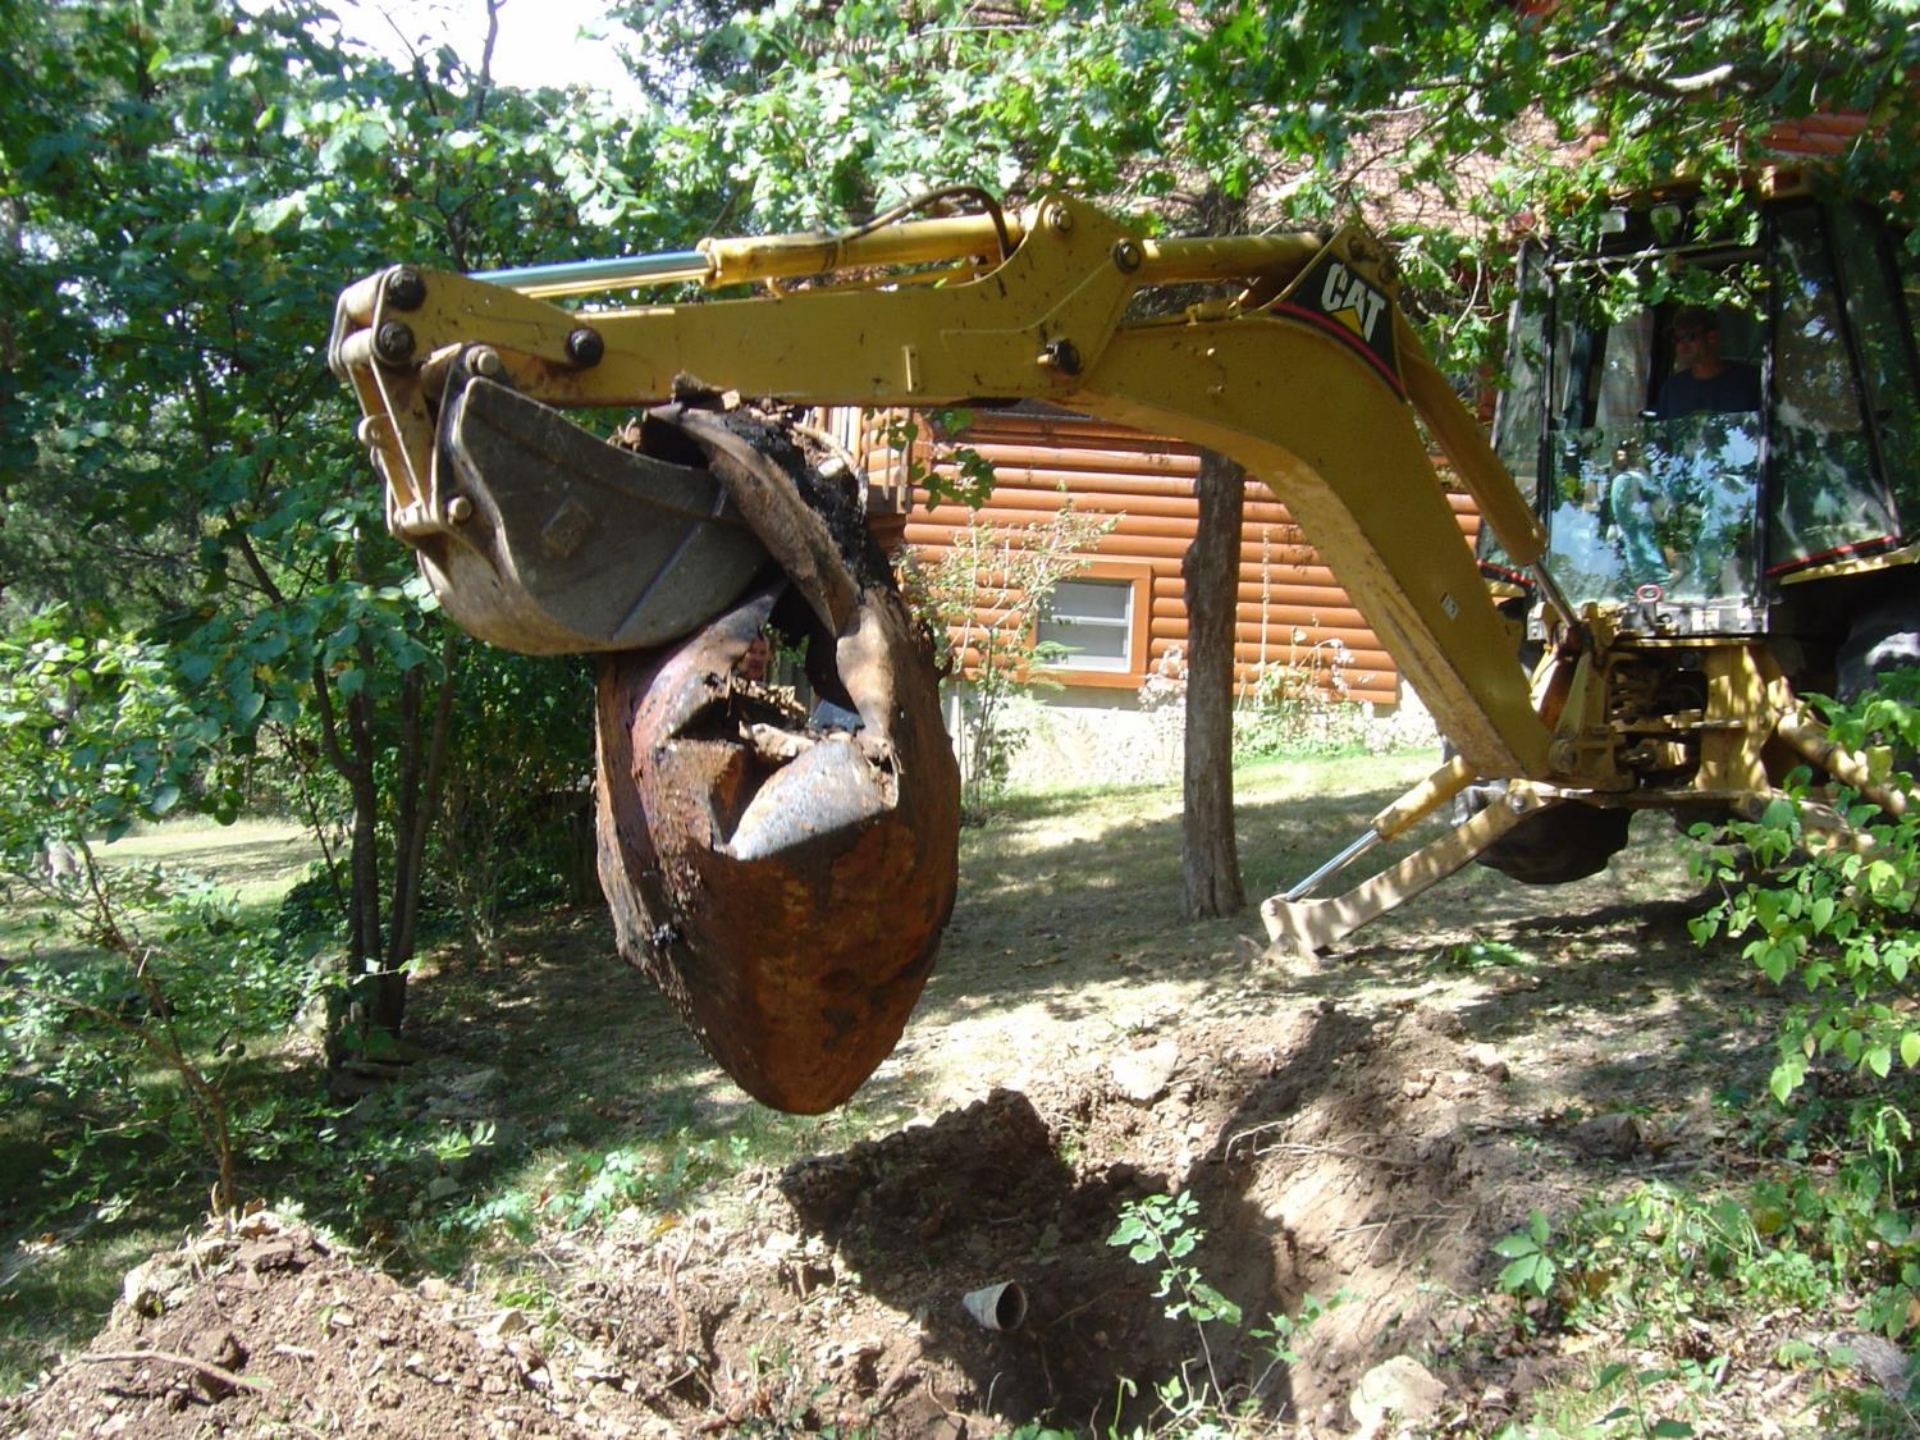
Right to left are untreated sewage, septic tank effluent, peat moss filter effluent (the color is tannin from the peat) and RetroFAST effluent.

Right to left are untreated sewage, septic tank effluent, peat moss filter effluent (the color is tannin from the peat) and RetroFAST effluent.

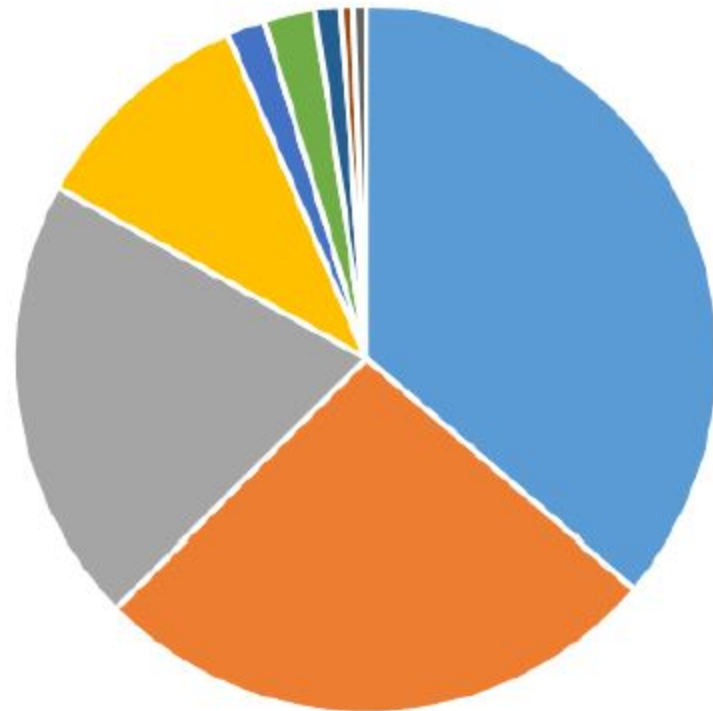
Systems by Type

Advanced Drip	62
Conventional	45
LPP	35
Tank Only	18
ATU Tank	3
Laterals only	4
ATU LPP	2
Pipe Repair	1
Lagoon	1

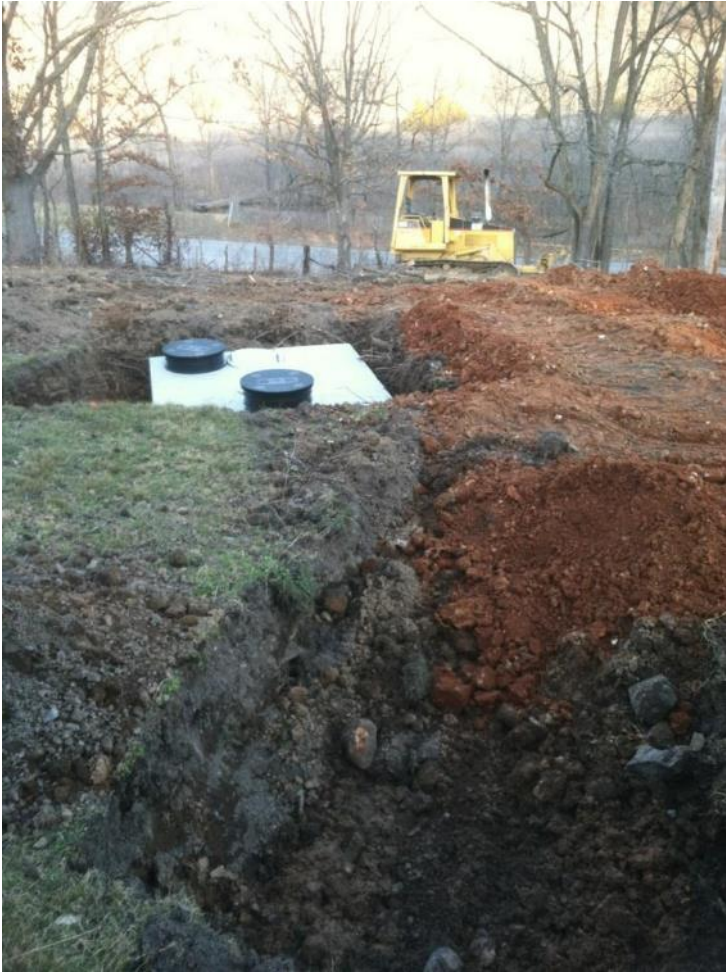
Advanced system with pump tank

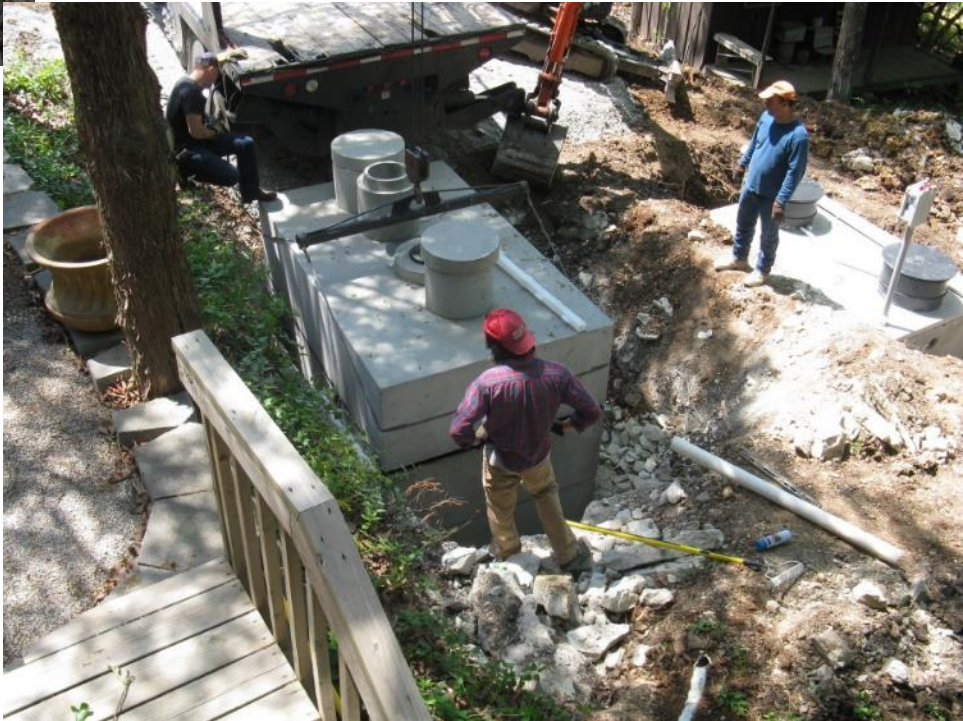
Advanced System with Drip Field
