An Evolving Wastewater Island in Henrico Co., VA

Wastewater Island

Windsor Subdivision

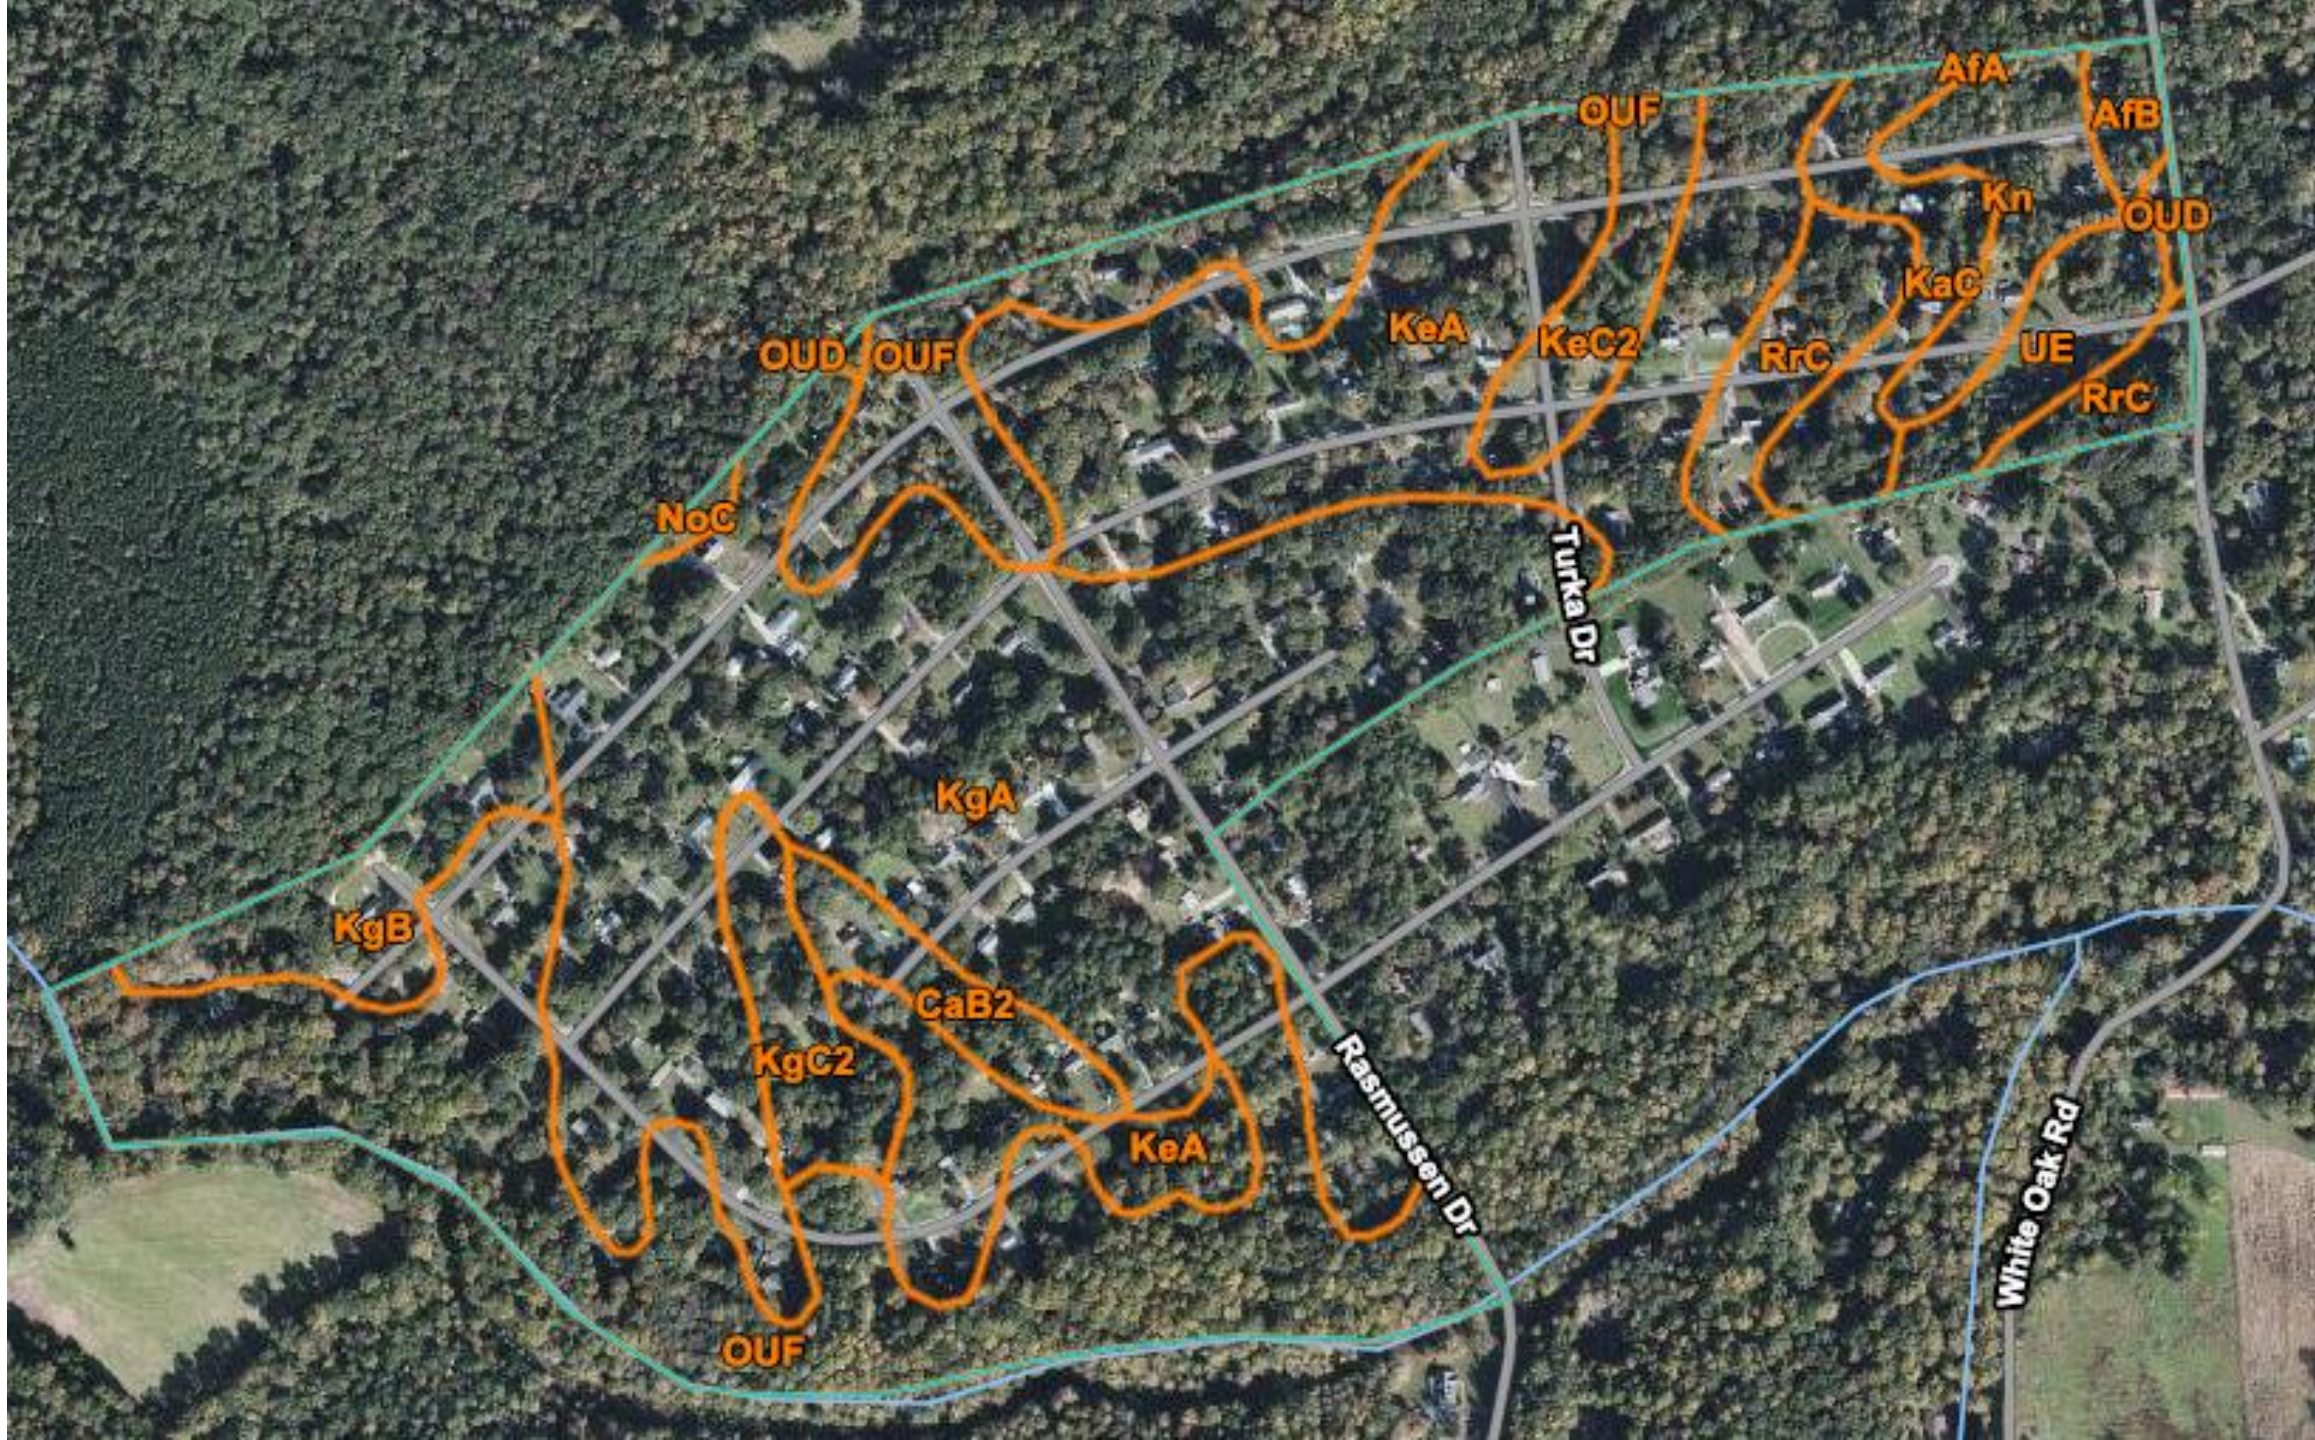
Map Unit Symbol	Map Unit Name	Acres in AOI	Percent of AOI
AfA	Altavista fine sandy loam, 0 to 2 percent slopes	0.0	0.0%
AfB	Altavista fine sandy loam, 2 to 6 percent slopes	1.2	0.8%
CaB2	Caroline very fine sandy loam, 2 to 6 percent slopes, eroded	3.0	2.0%
KaC	Kalmia fine sandy loam, 2 to 10 percent slopes	4.8	3.1%
KeA	Kempsville fine sandy loam, 0 to 2 percent slopes	28.4	19.2%
KeC2	Kempsville fine sandy loam, 2 to 10 percent slopes, eroded	3.6	2.4%
KgA	Kempsville very fine sandy loam, clayey substratum, 0 to 2 percent slopes	47.1	31.8%
KgB	Kempsville very fine sandy loam, clayey substratum, 2 to 6 percent slopes	5.1	3.4%
KgC2	Kempsville very fine sandy loam, clayey substratum, 6 to 10 percent slopes, eroded	3.8	2.6%
Kn	Kinston and Mantachie soils	4.5	3.0%
NoC	Norfolk fine sandy loam, 6 to 10 percent slopes	0.3	0.2%
OUA	Nevarc-Remlik complex, 6 to 15 percent slopes	0.5	0.3%
OUF	Nevarc-Remlik complex, 15 to 50 percent slopes	37.4	25.2%

RrC	Rumford loamy sand, 0 to 10 percent slopes	5.2	3.5%
UE	Udorthents, loamy	3.3	2.3%
Totals for Area of Interest		148.0	100.0%

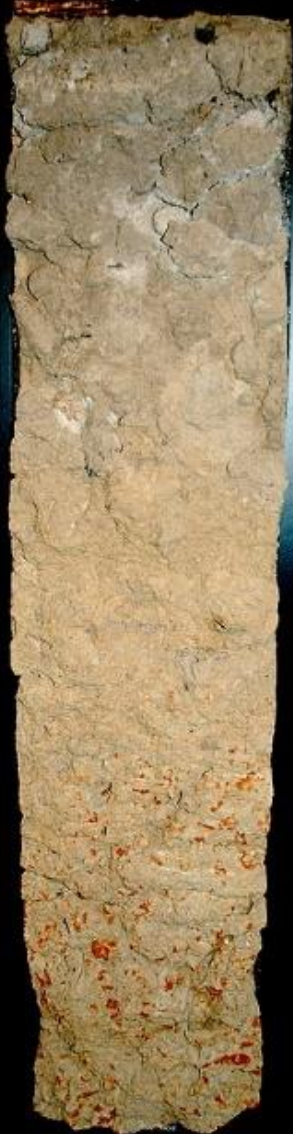
Current soil profile showing a Plinthosol with the beginning formation of plinthite lower in the soil profile.

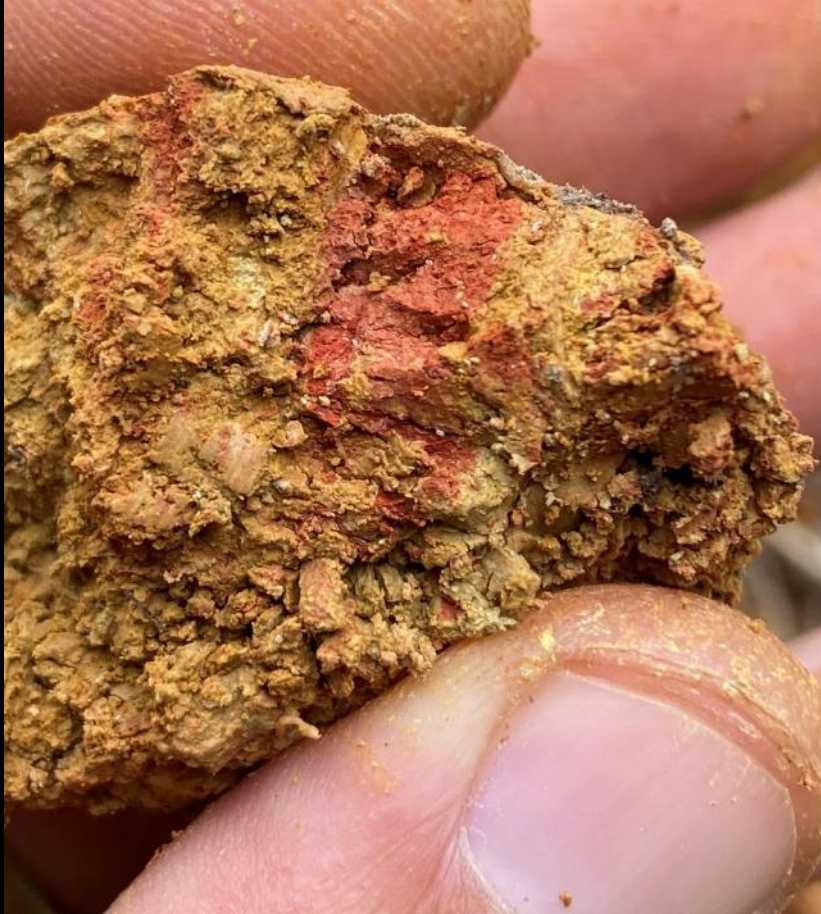
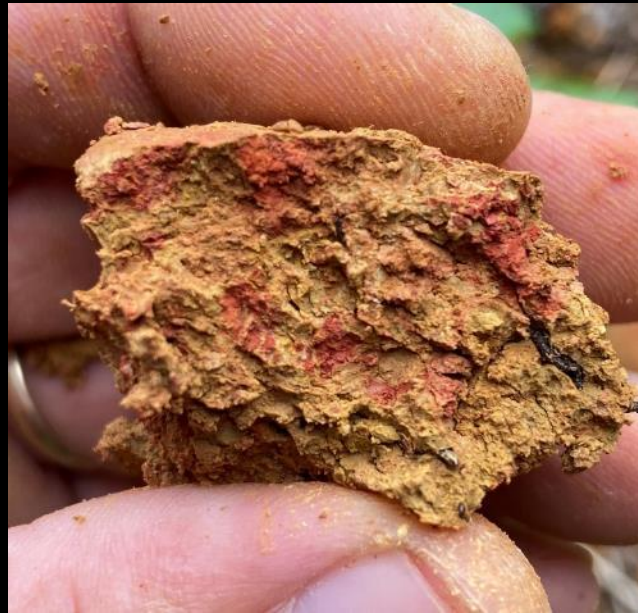
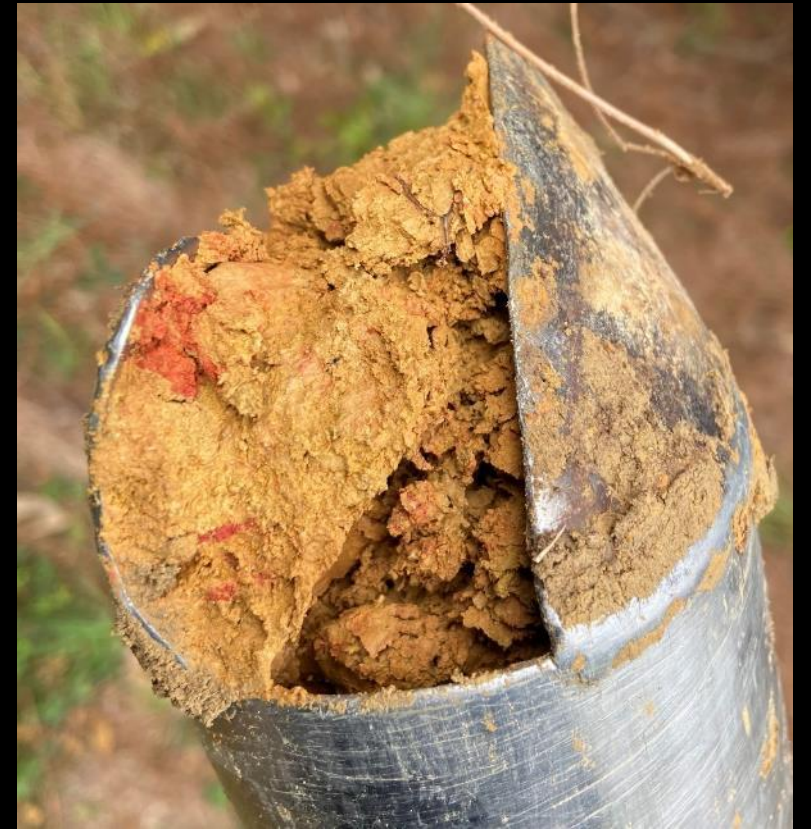
Cut bank showing reticulated relict features further down in the soil profile

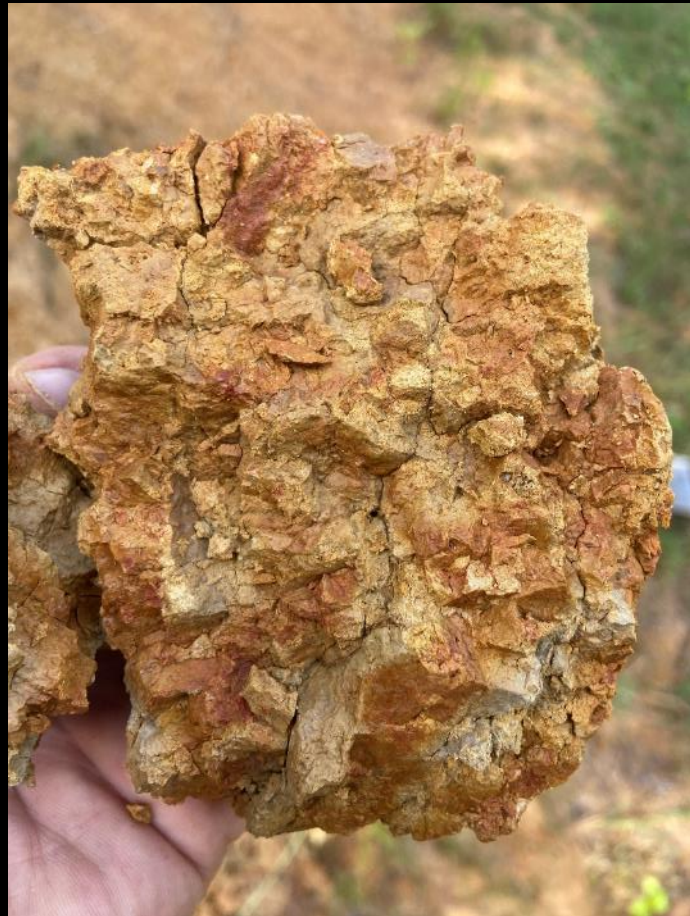
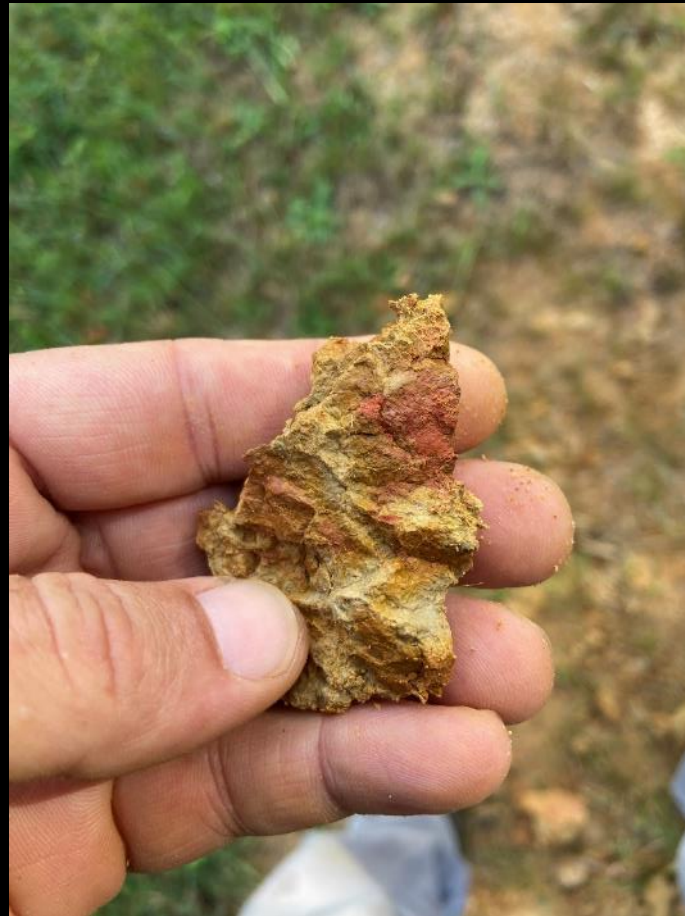
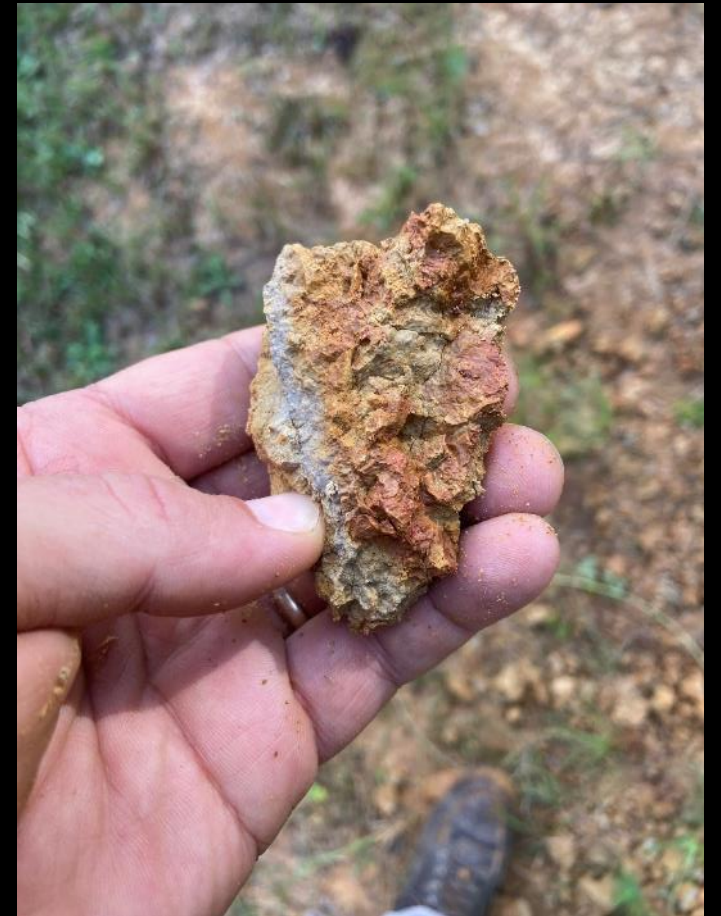
Uniform soil matrix with the first signs of relict features appearing in the lower right.
