Advanced Treatment Systems Uncovered: Pitfalls, Solutions, and Success Stories.

Lucas Caldwell, O&M Manager Septic Check

Introduction to ATU'S

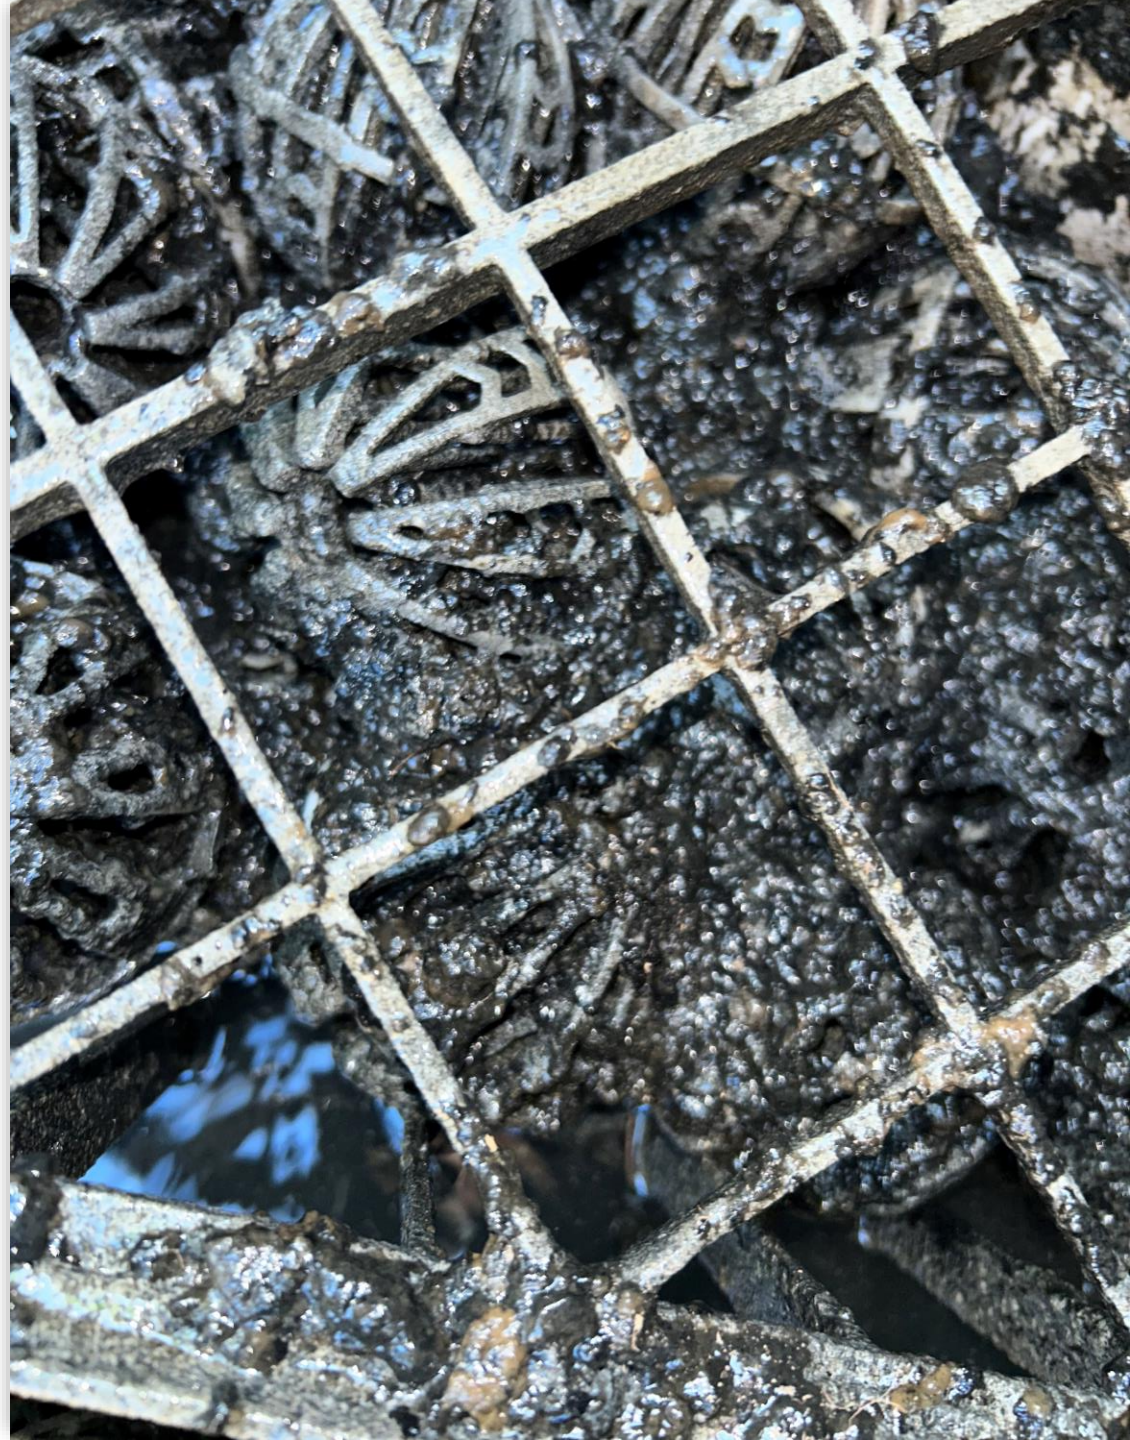
Case Study - Residential Nibbler System

- Homeowner faced system failures and conflicting advice.
- Lacked system records or an operating permit.
- We educated her on her system, repaired the pump and blower, and established a bi-annual service agreement.

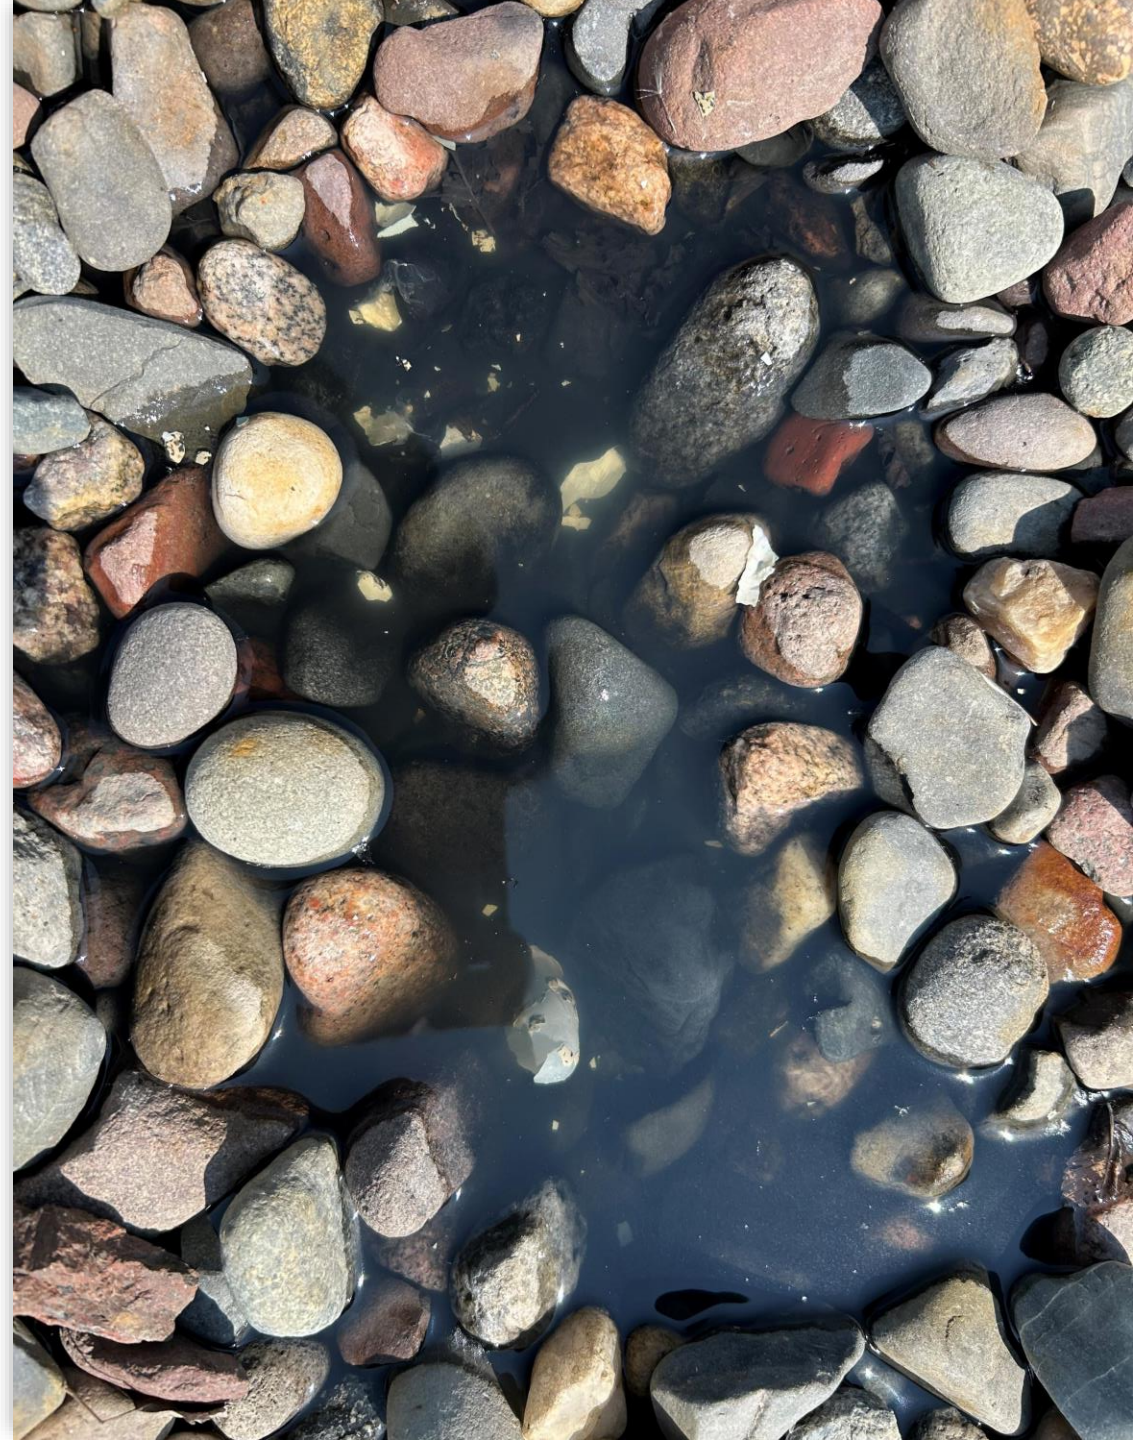
Case Study – Commercial Recirculating Gravel filter System

- The customer's system is over 15 years old and has undergone multiple upgrades throughout its lifespan. It has also experienced several changes in restaurant ownership, with each new owner introducing different waste streams and usage patterns. After conducting several repairs on the existing system, we discovered that the recirculation filter was severely bio-matted and non-functional in its current condition.
- Significant education was needed to help the owner understand the history of the system, the factors that contributed to its current state, and the challenges they were facing. Through our thorough assessment, we were able to recommend targeted repairs that restored the system's functionality, ultimately saving the customer \$2,000 per week in pumping fees.

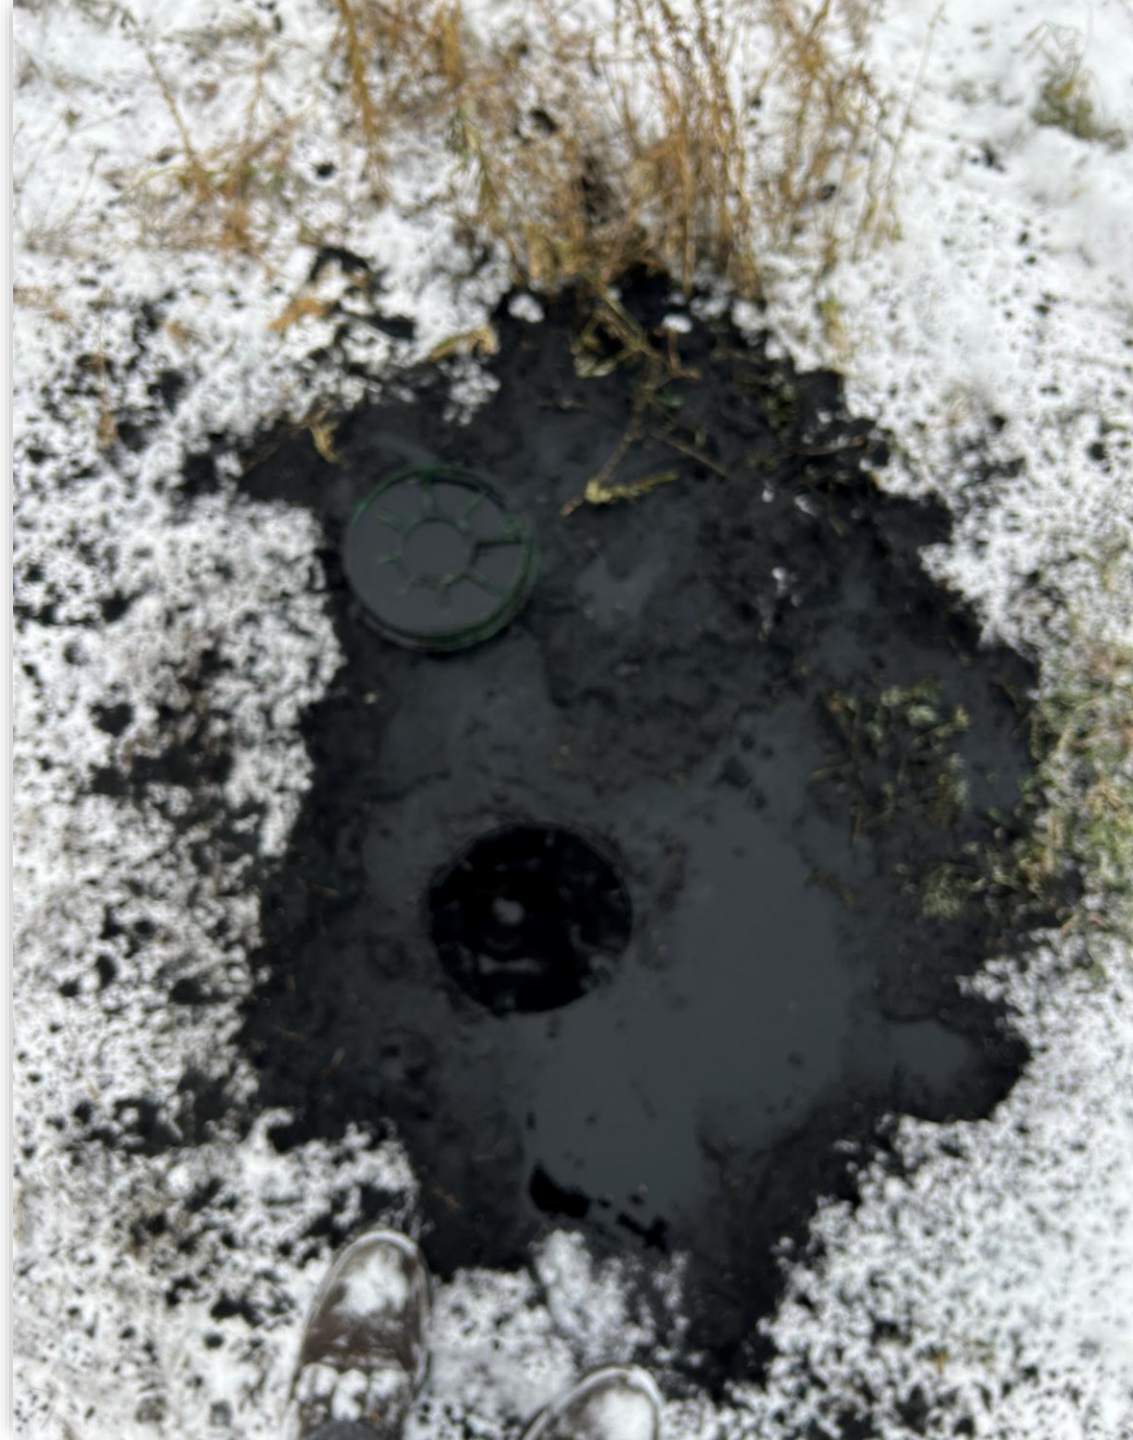
Case Study – LSTS Recirculation Wetland Filter System

- The wetland recirculating filter system was installed to serve around 90 homes in the homeowners association. However, the system sat idle for several years before it was ever put into use. Once the system was finally brought online, it began struggling almost immediately to meet its nitrogen permit limit of 10 mg/L.

- As time went on and the system remained out of compliance, additional problems started to appear. It became clear that the placement and overall design of the soil treatment area (STA) were poor choices, and the construction techniques used during installation further contributed to the system's premature decline.

- Over the years, countless operational changes were attempted and several repairs were made in an effort to bring the system back into compliance. Despite these efforts, the system never achieved consistent performance and continued to fail. Eventually, the entire system had to be completely redone at significant cost to the HOA.
