# Lessons Learned from Commercial Sampling

DR. SARA HEGER

Presented at NOWRA 2025 Mega-Conference, October 19-22, 2025.

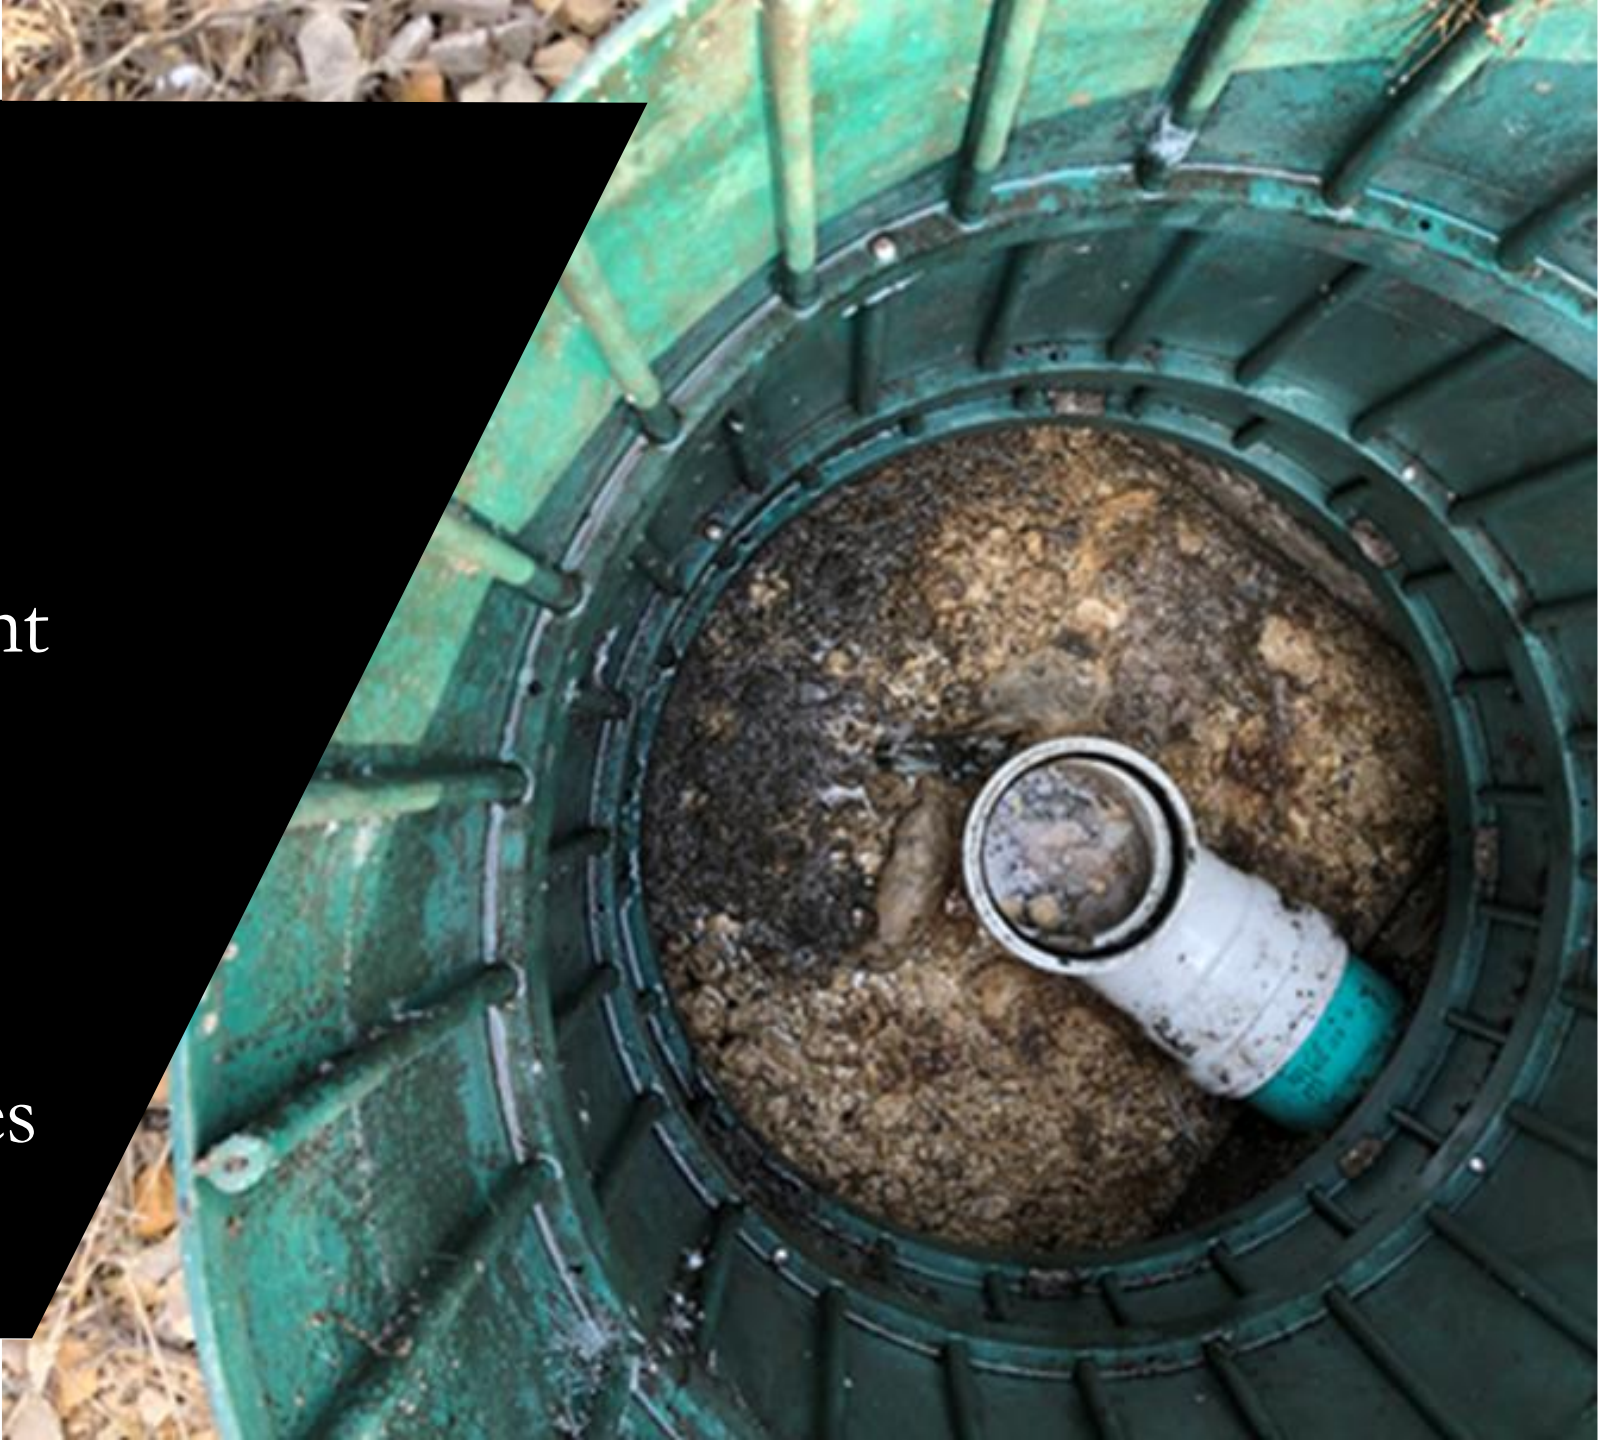
Getting into the Clear  
Zone for Raw Samples

Representative Influent  
Samples are very  
Difficult to Collect

- The raw influent samples were collected from the first septic tank in series on the inlet side
- The settled influent samples were collected from the EQ tank- except for one system that did not have an EQ tank then it was taken near effluent screen at outlet of last septic tank
- The effluent samples were collected from the field dosing tank

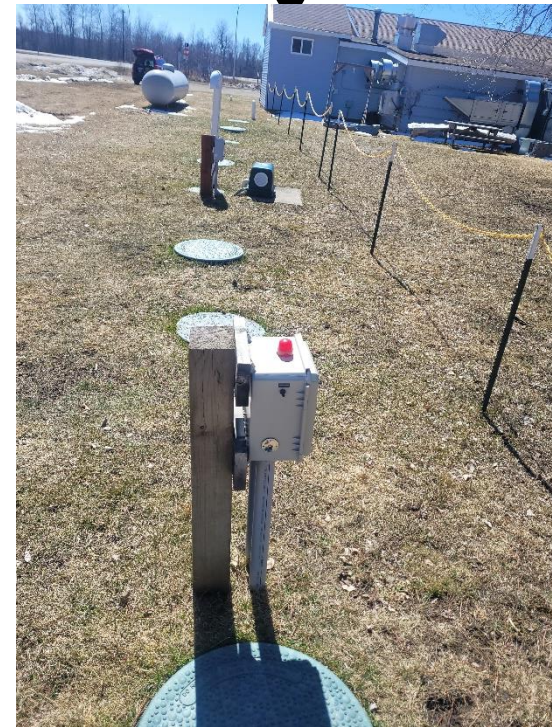
## TREATMENT TRAIN

- This facility was an existing bar and grill, and a new system was put in with a change in ownership
  - The menu proposed during the design process was minimal, consisting of frozen pizzas and other small items
- That is NOT what happened

- On the initial site visit it was noted that the system did not appear to have had any maintenance for some time, owner has no service contract
- The food service included burgers, fries, and other bar and grill fare but also broasted chicken every weekend and a fish fry one Friday a month
- This type of menu would be expected to produce a much higher influent BOD5 than was estimated.
- High TSS values likely due to lack of flow eq

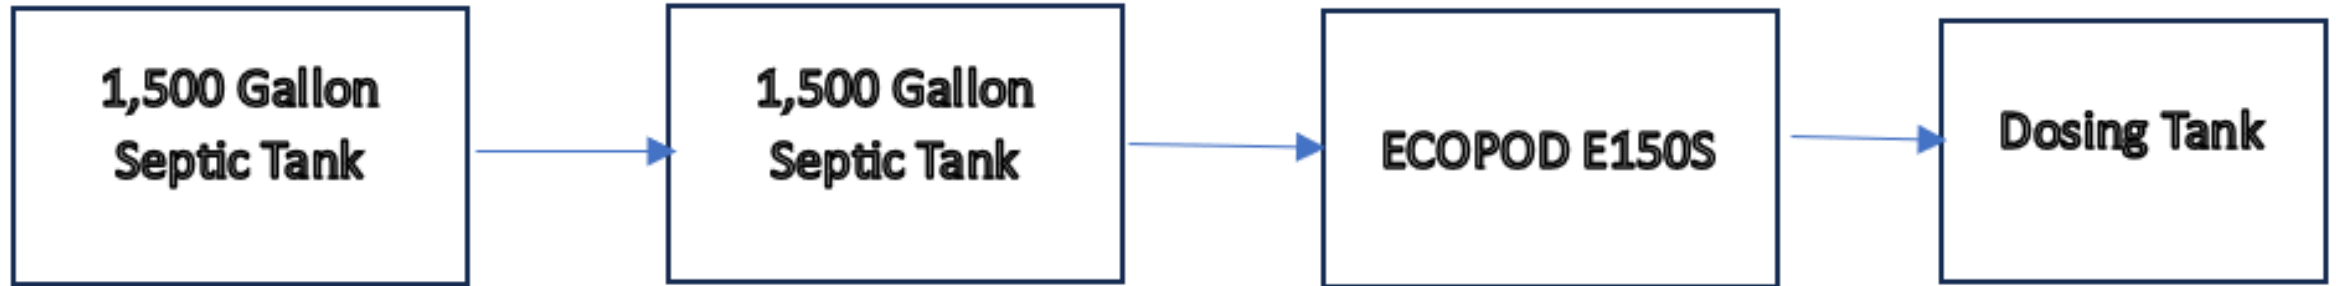
## System Layout:

NO FLOW EQ

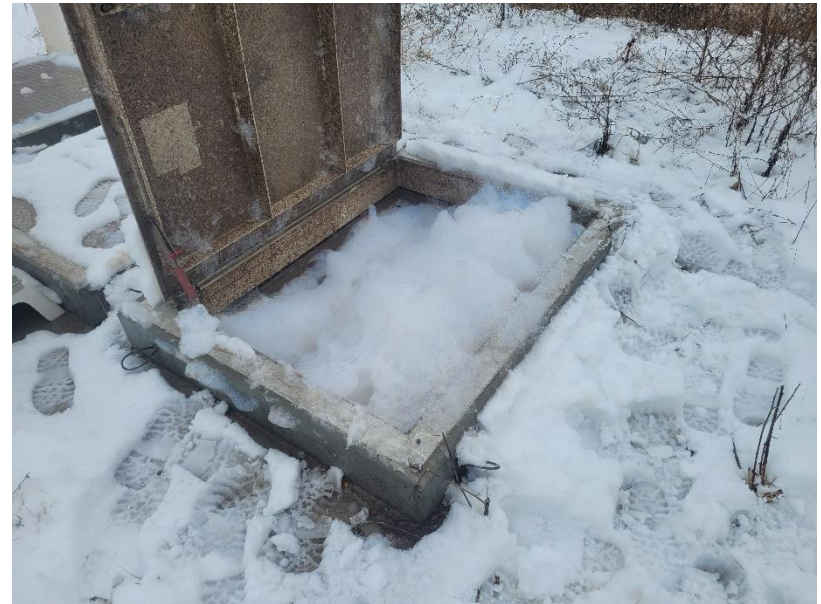
## SOAP ISSUES

- New taproom with minimal food
- The menu proposed during the design process was minimal
  - That is NOT what happened

- The ECOPOD unit did not have the influent dosing line plumbed into the distribution line over the media
  - Appeared that brewery waste was entering the system vs holding tank
  - No service contract
  - Since opening, the facility has expanded their food service somewhat to include smash burgers on some Friday nights
  - Regularly host events
  - Flow eq tank was always empty when sampling occurred except after a holiday event
  - Excessive foaming has indicated an overuse of cleaning products
-
