Onsite Wastewater Mega-Conference | 2023
Hampton, Virginia

Research on septage and bioaugmentation

Dr. Sara Heger

UNIVERSITY OF MINNESOTA

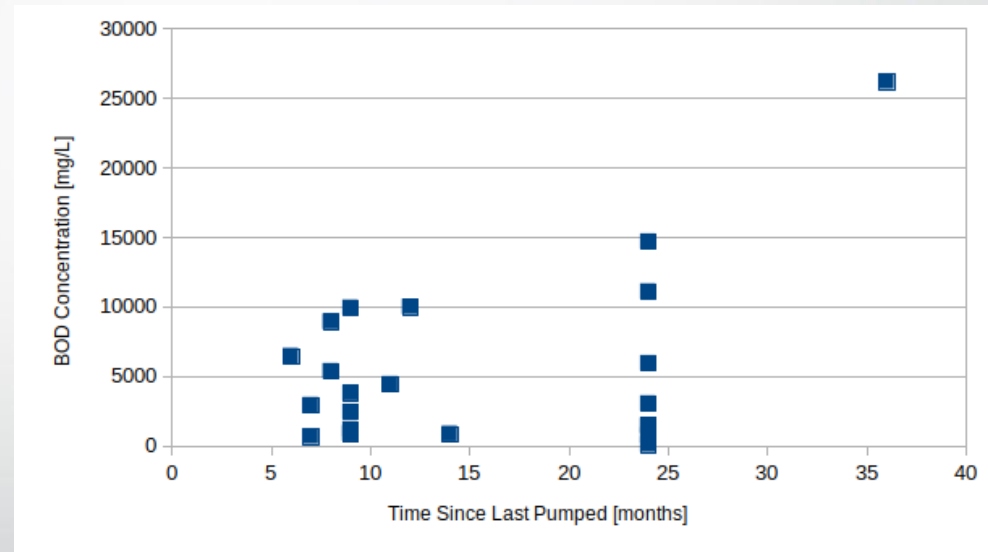
BOD vs. months since tank pumped

- Maximum values trend upward
- Little overall correlation
($R^2 < 0.19$)

- Maximum concentrations tend to increase with longer periods between pumping (for all parameters except oil and grease, pH)
- Little to no overall correlation between concentrations and time between pumping

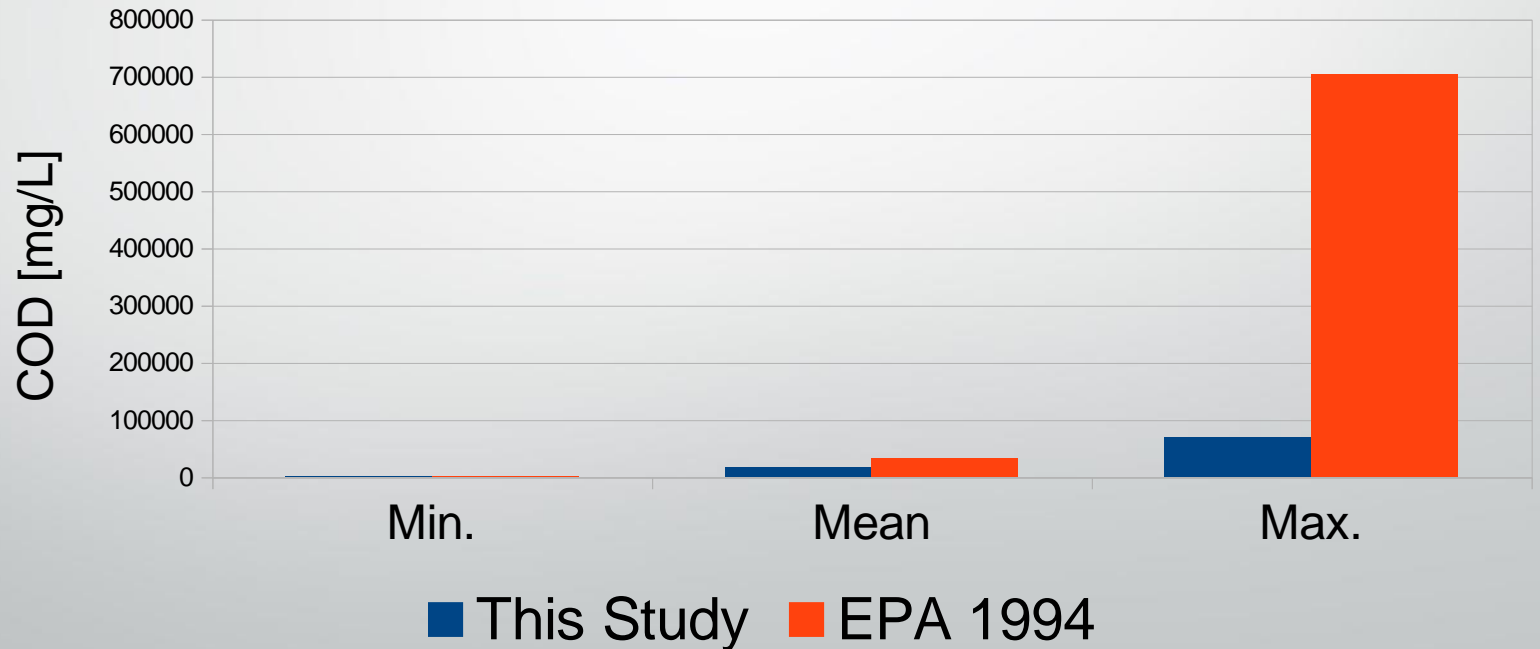
Results: COD

- Mean values similar to EPA mean
- No extraordinarily high values

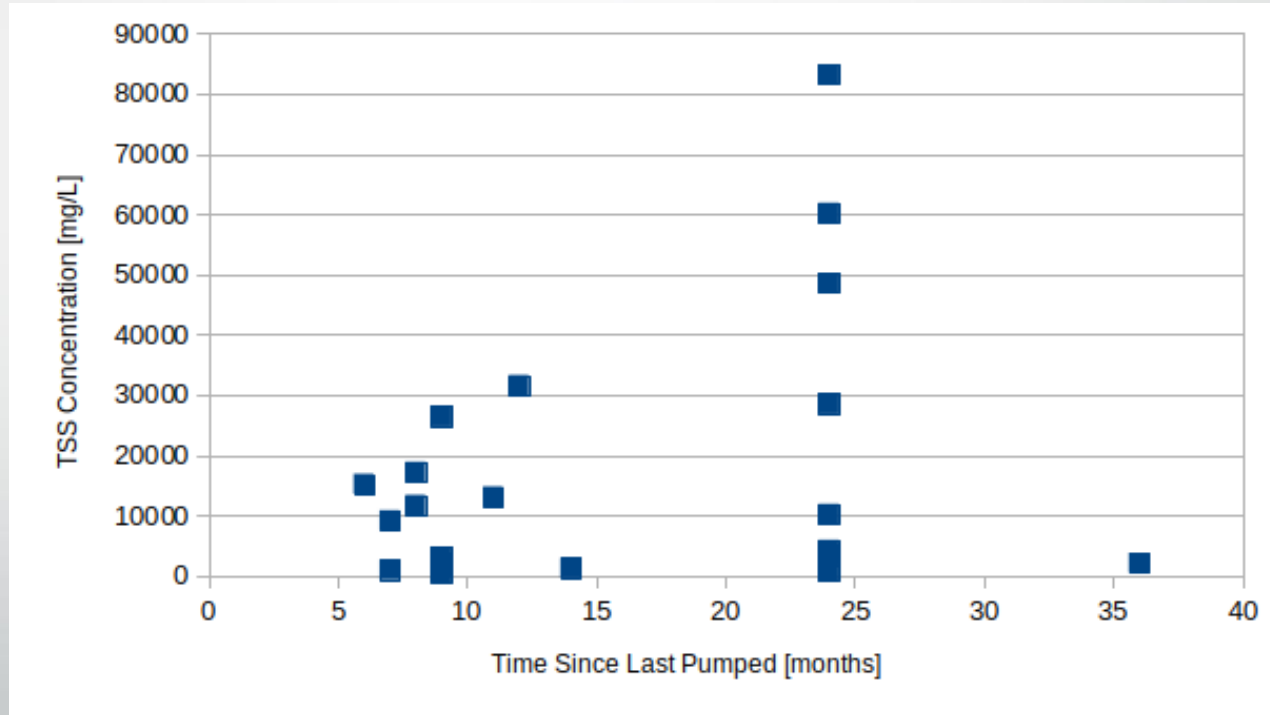
TSS vs months since tank pumped

- Maximum trends up
- No overall correlation
- Same trends as BOD and COD

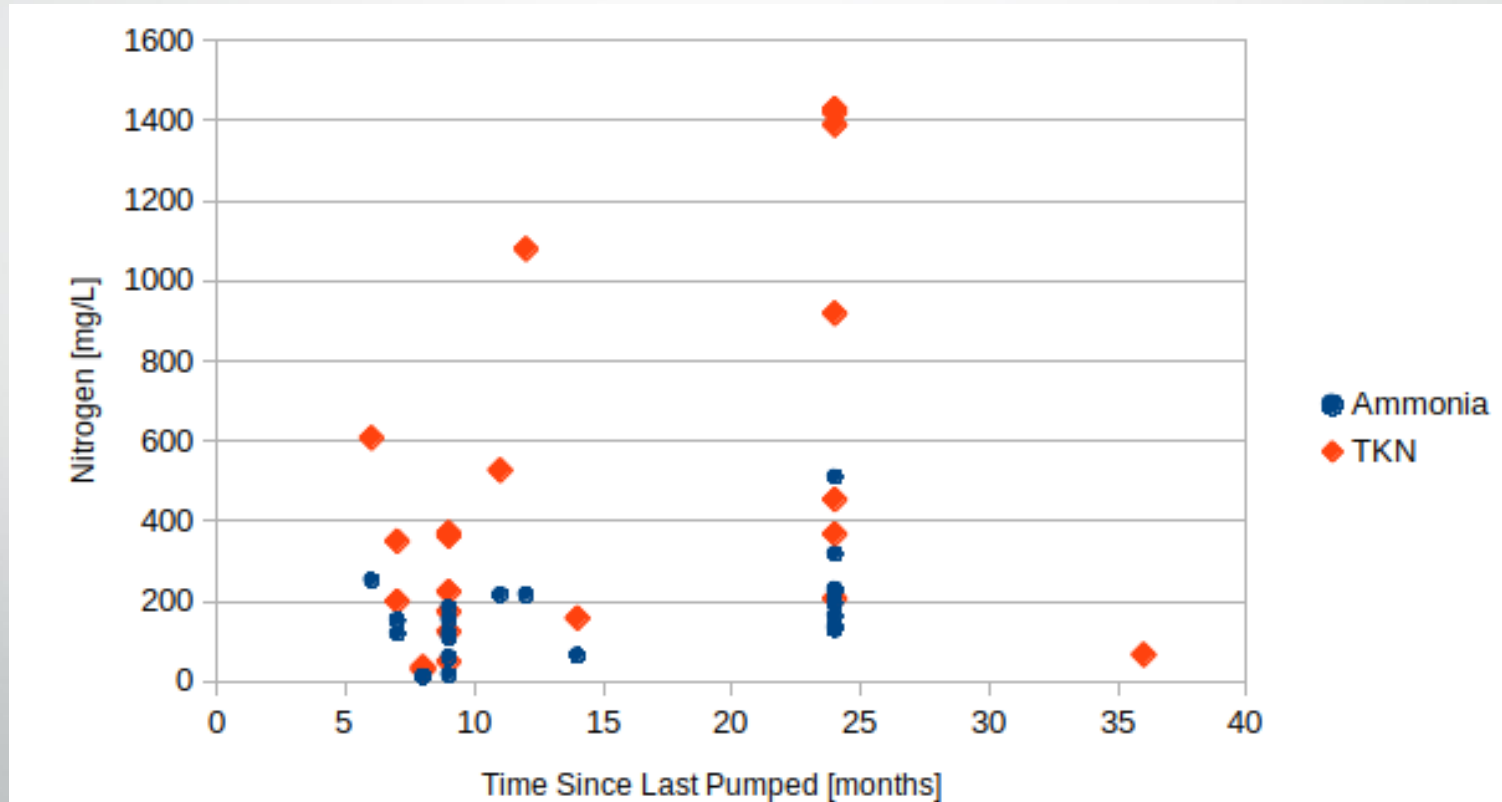
Nitrogen vs months since pumped

Same trends as BOD, COD, TSS

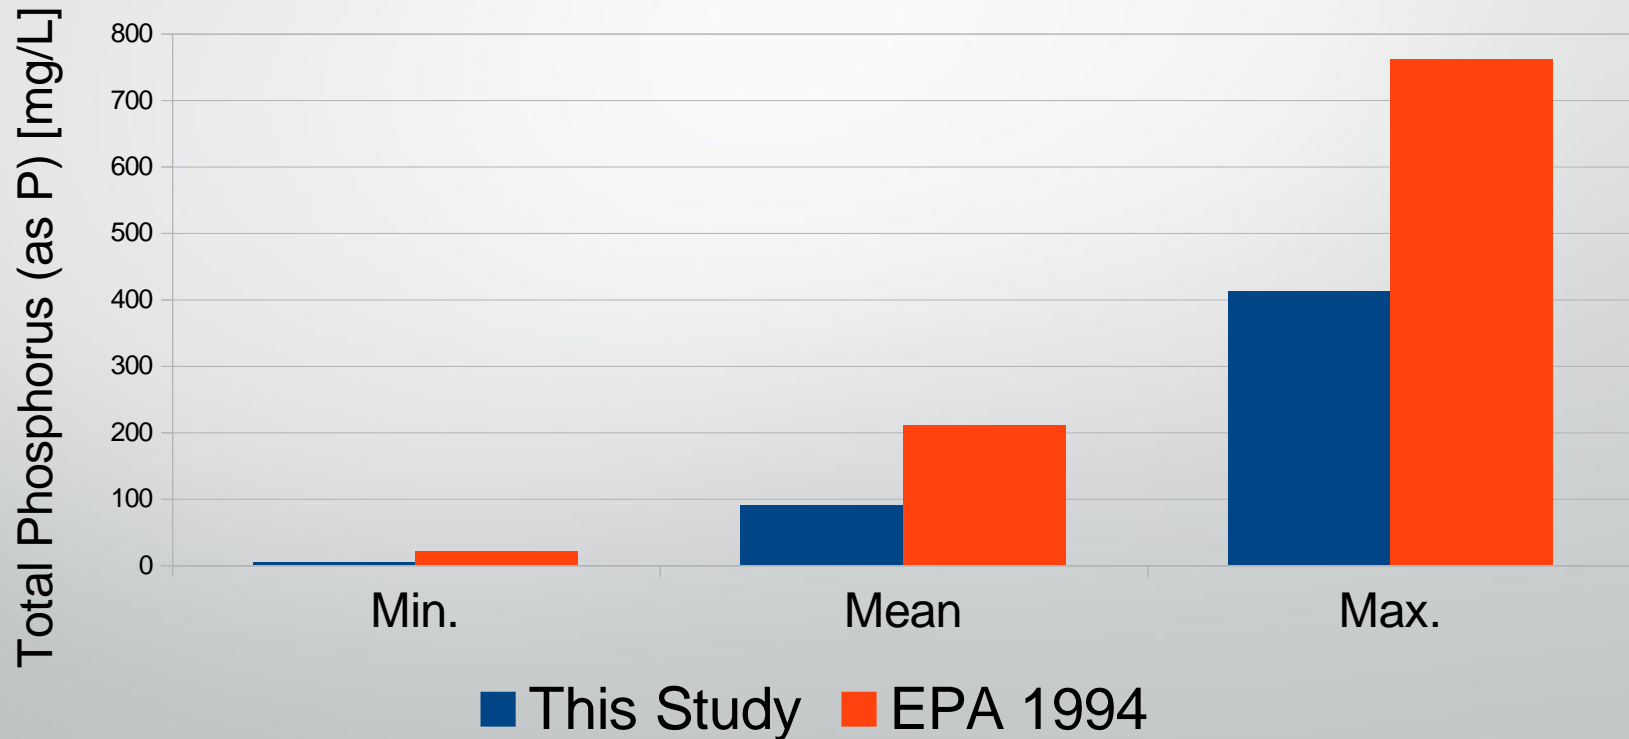
Results: Phosphorus (total as P)

- Consistently lower than EPA 1994

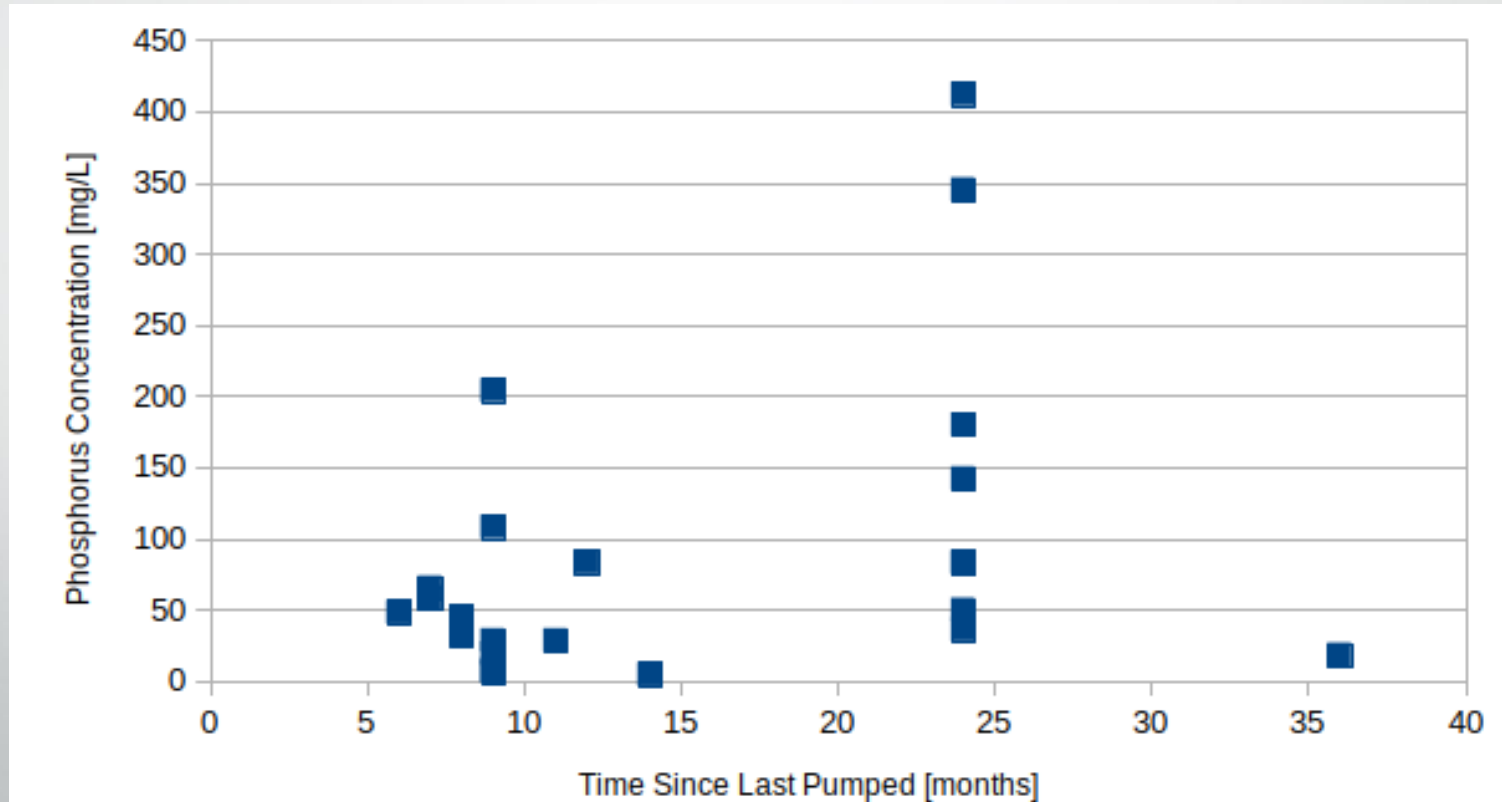
Phosphorus vs months since tank pumped

Same trends as BOD, COD, TSS, nitrogen)

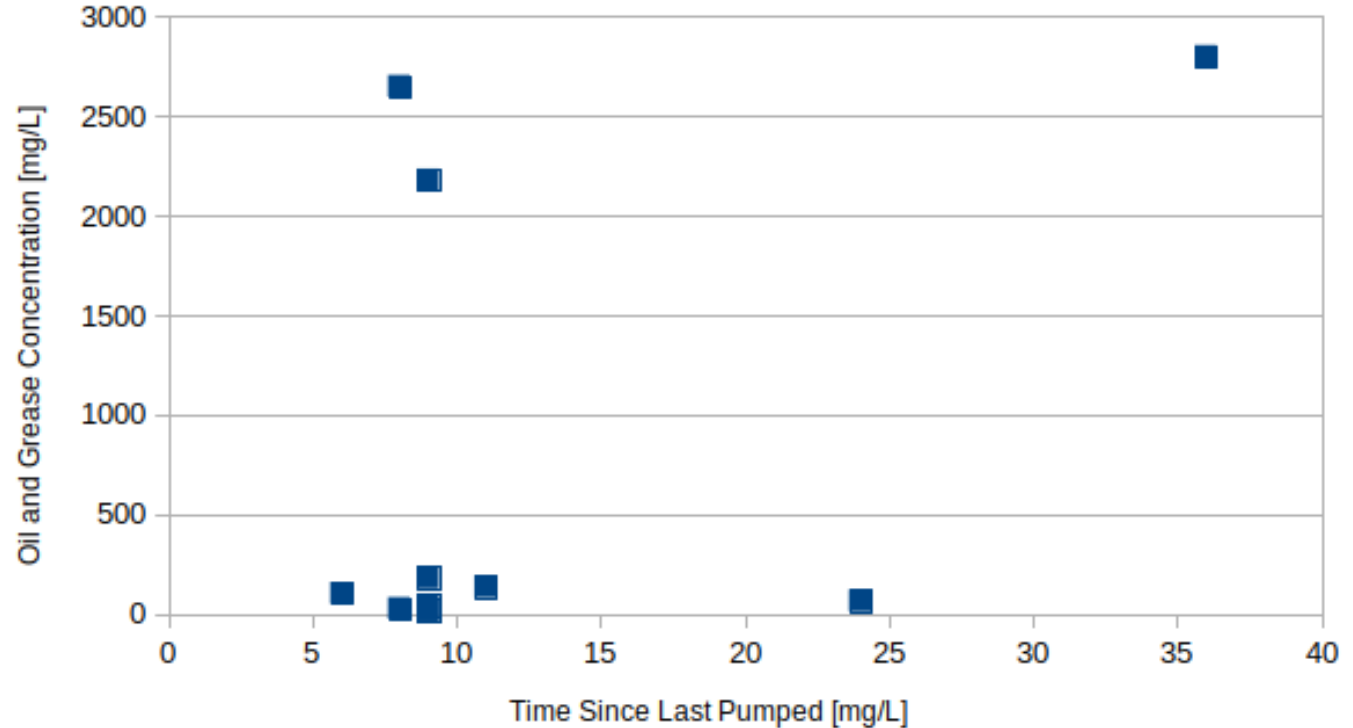
Oil and grease vs months since tank last pumped

Trends less obvious

Still little to no correlation

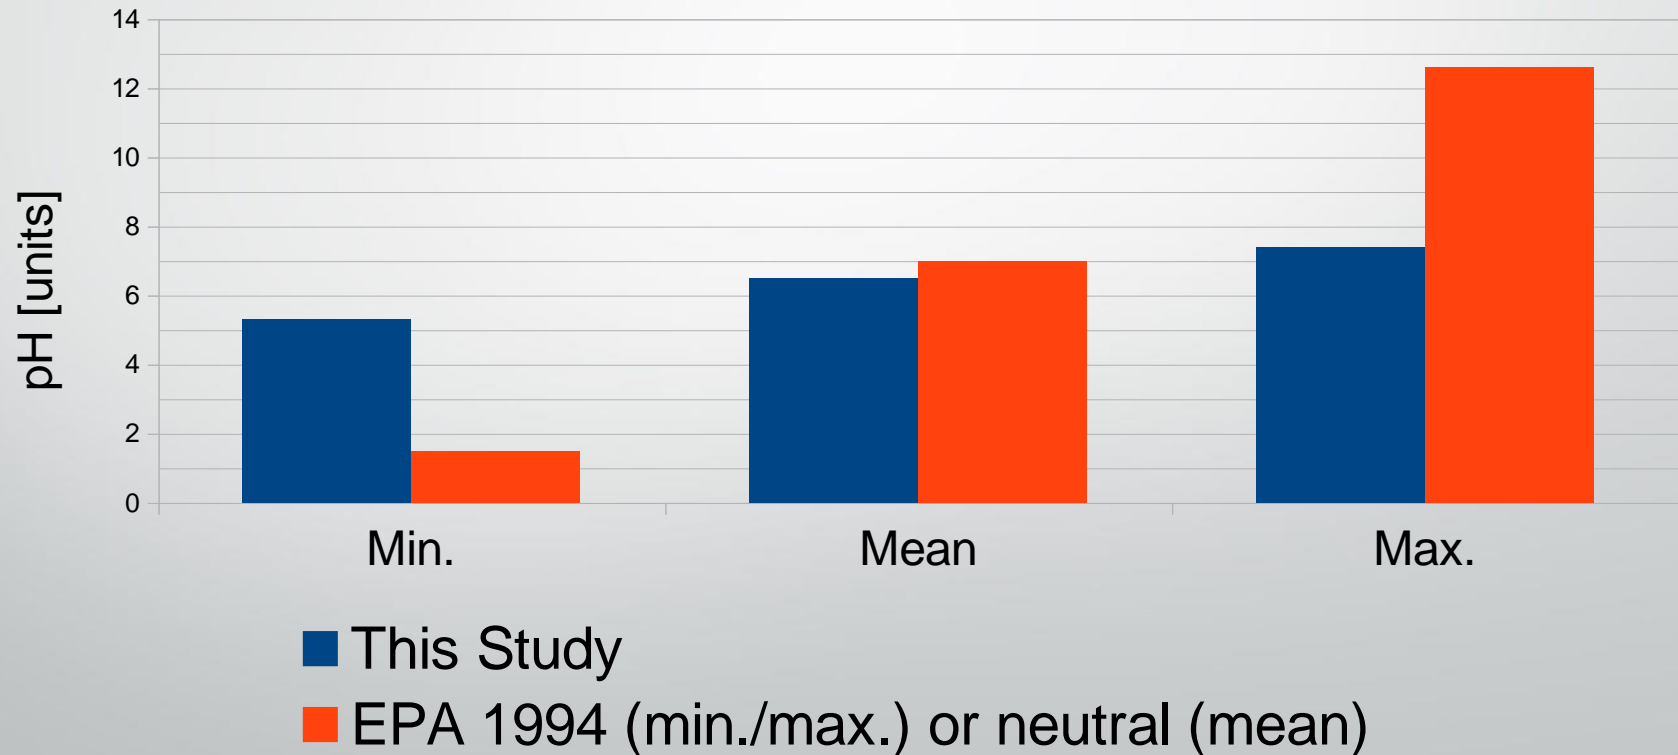
Results: pH

- Well within range of EPA 1994

Scale is linear

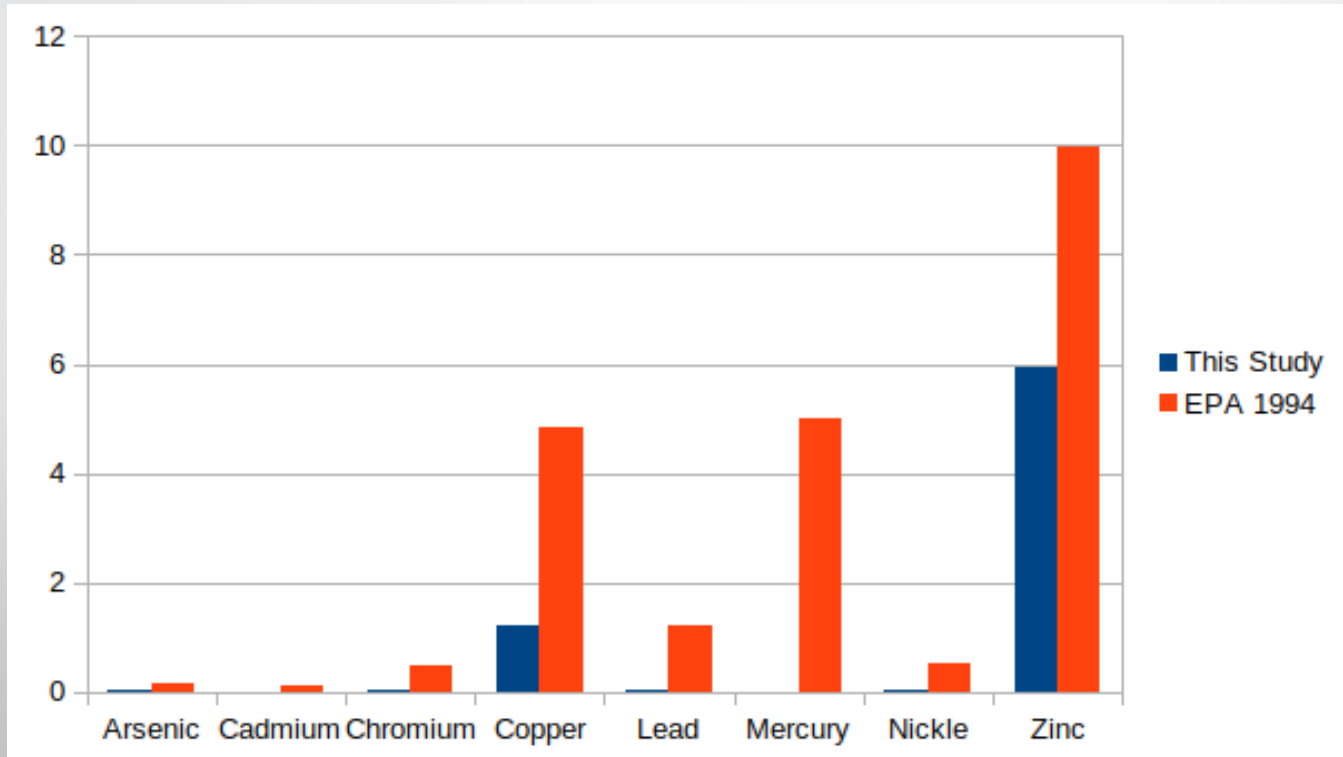
Results: Metals – Mean Concentrations

- Copper and zinc detected at all sites; other metals not detected at most
- No mean concentrations above EPA mean
- Two individual zinc concentrations above EPA mean; none above EPA maximum
- High coefficients of variation (concentrations variable relative to own values)

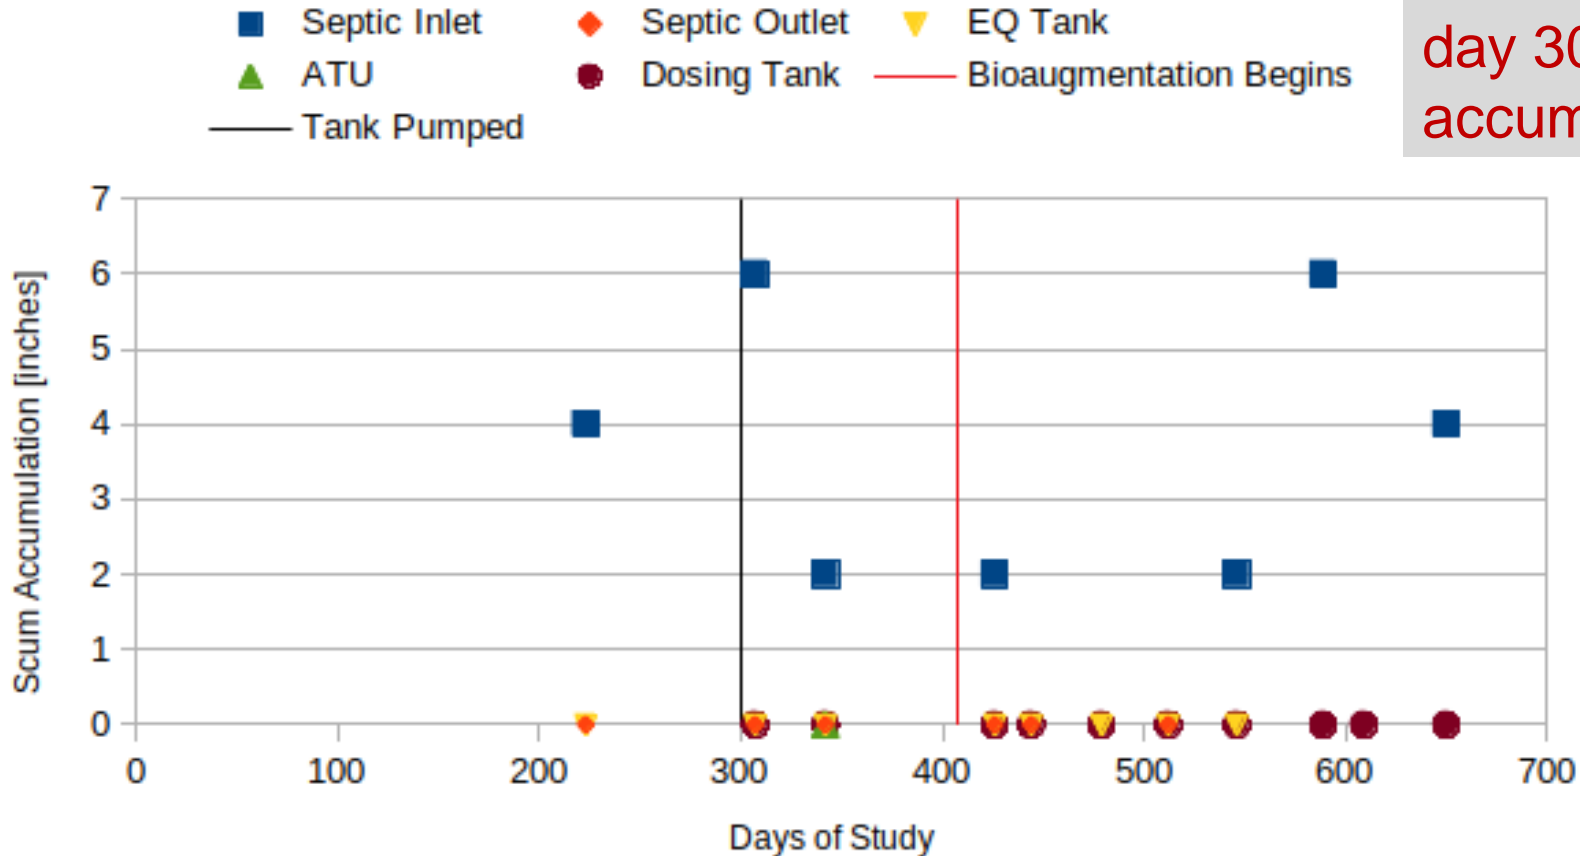
Goose Creek: Results – Scum Accumulation

Scum drops when tank is pumped (near day 300) but may be accumulating again

No clear trend in scum accumulation

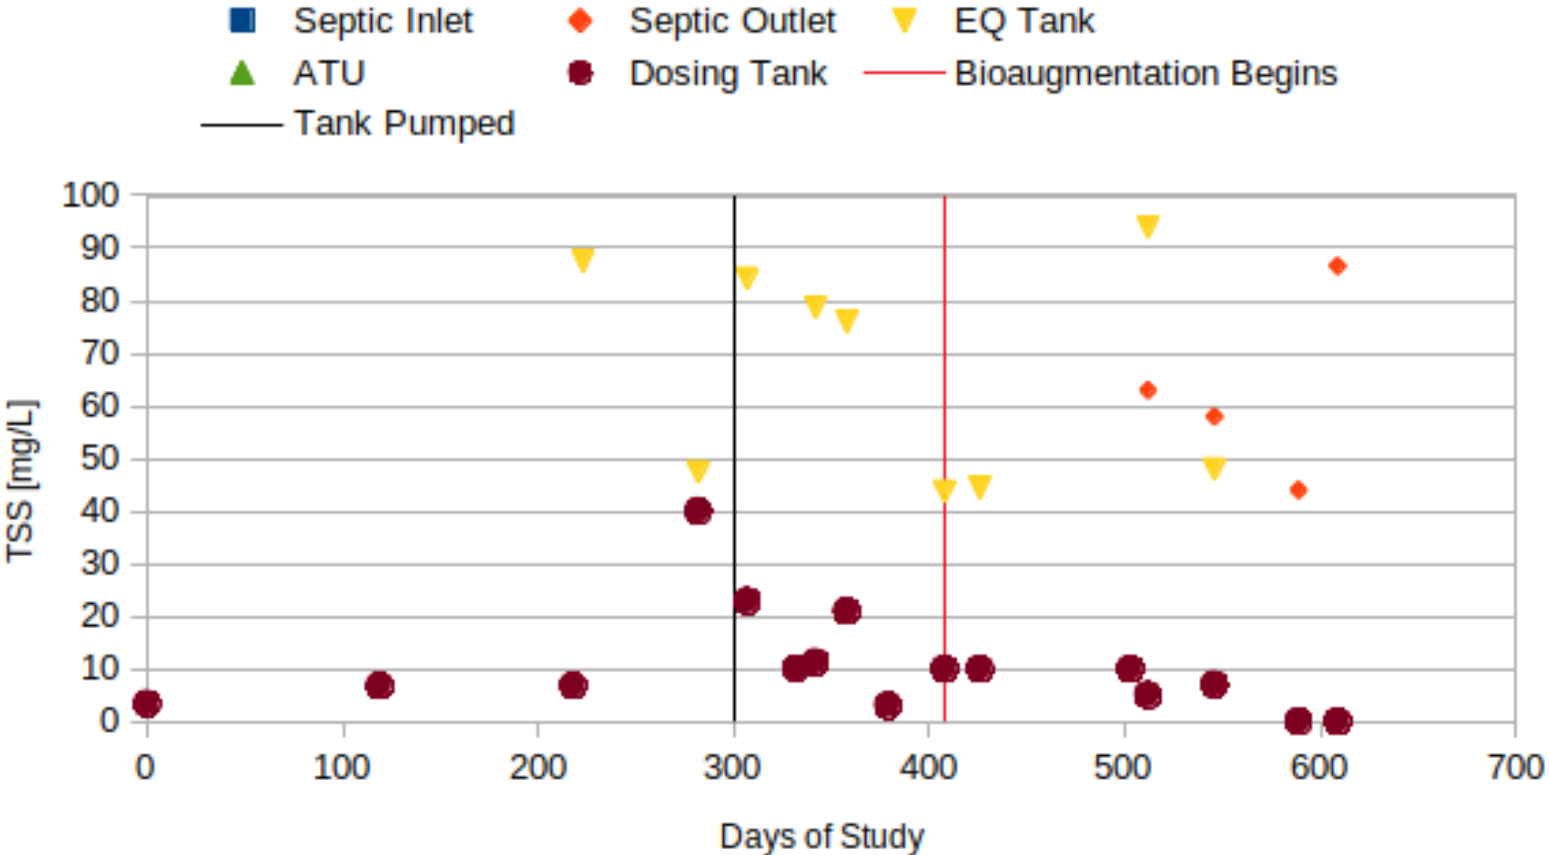
Goose Creek: Results – TSS

TSS levels are stable

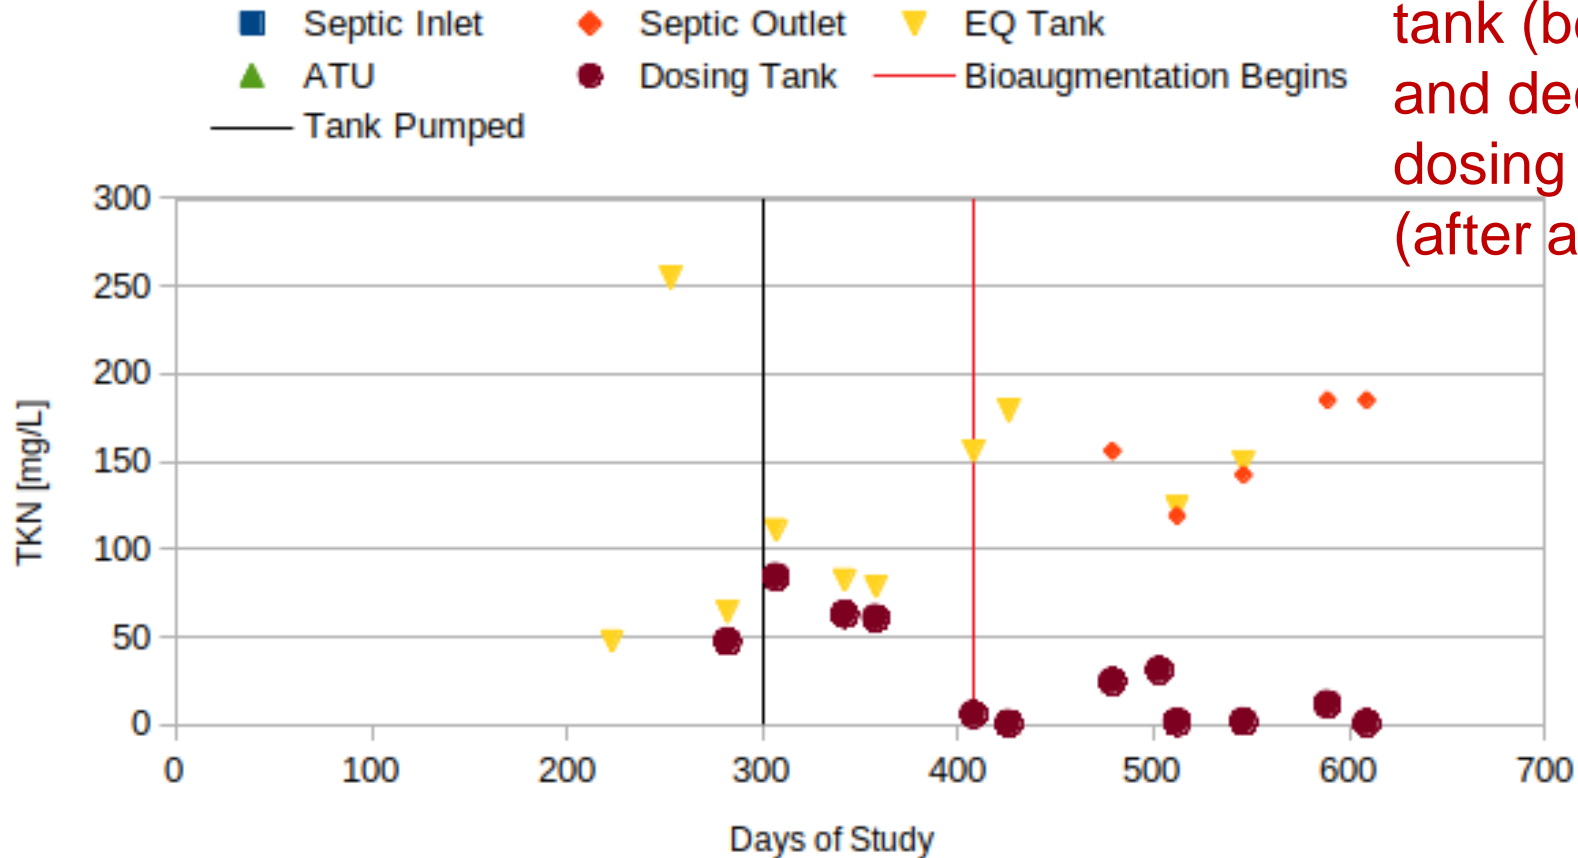
Goose Creek: Results – TKN

TKN increasing in EQ tank (before aeration) and decreasing in dosing tank (after aeration)

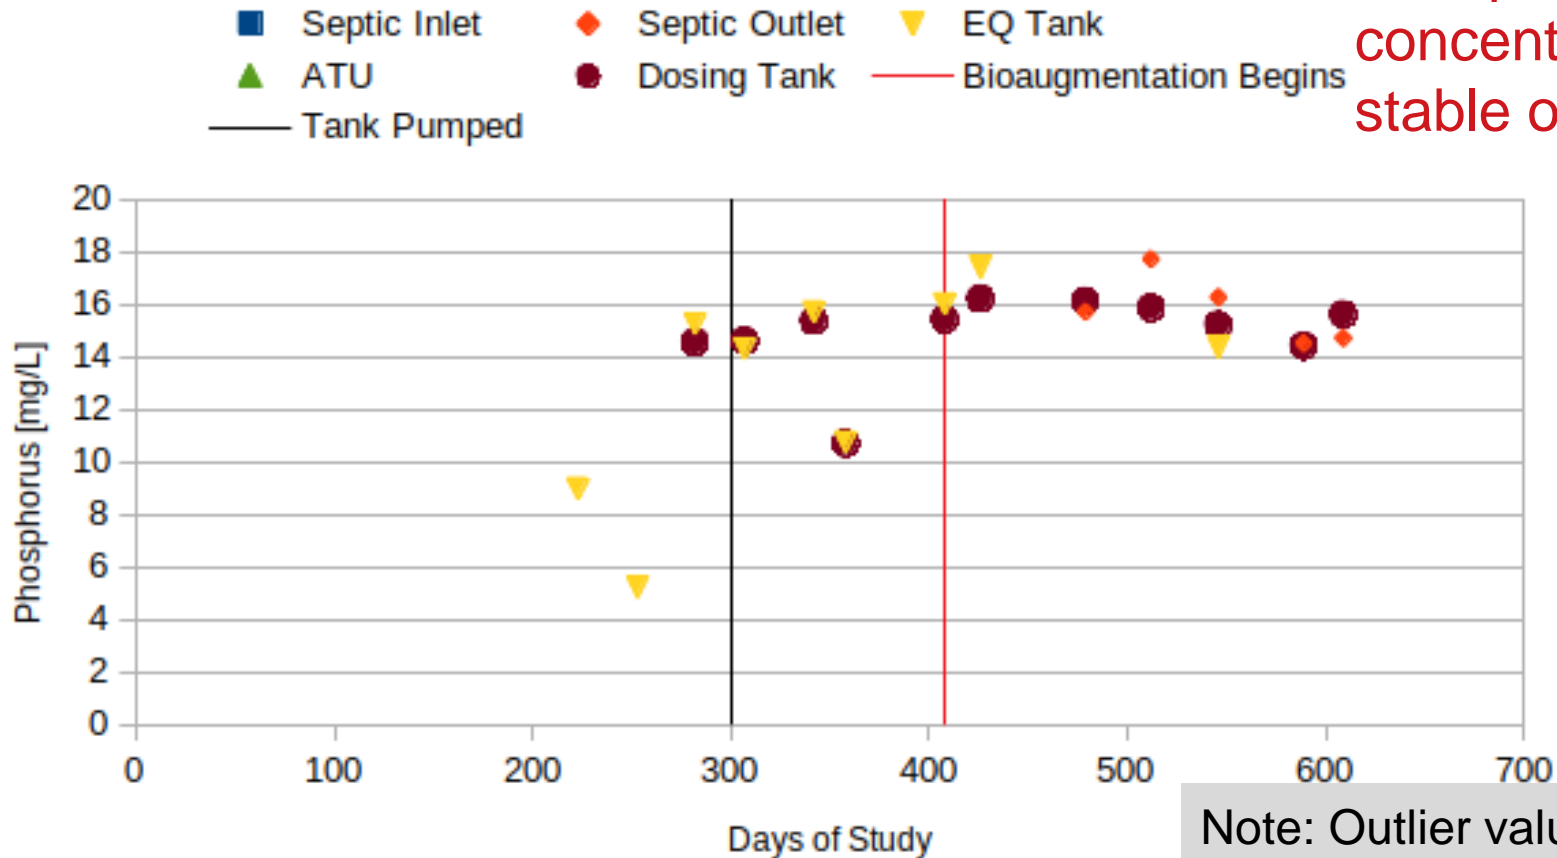
Goose Creek: Results – Phosphorus

Phosphorus concentration appears stable or decreasing

Note: Outlier value of 150 [mg/L] in EQ tank on Day 512 not shown

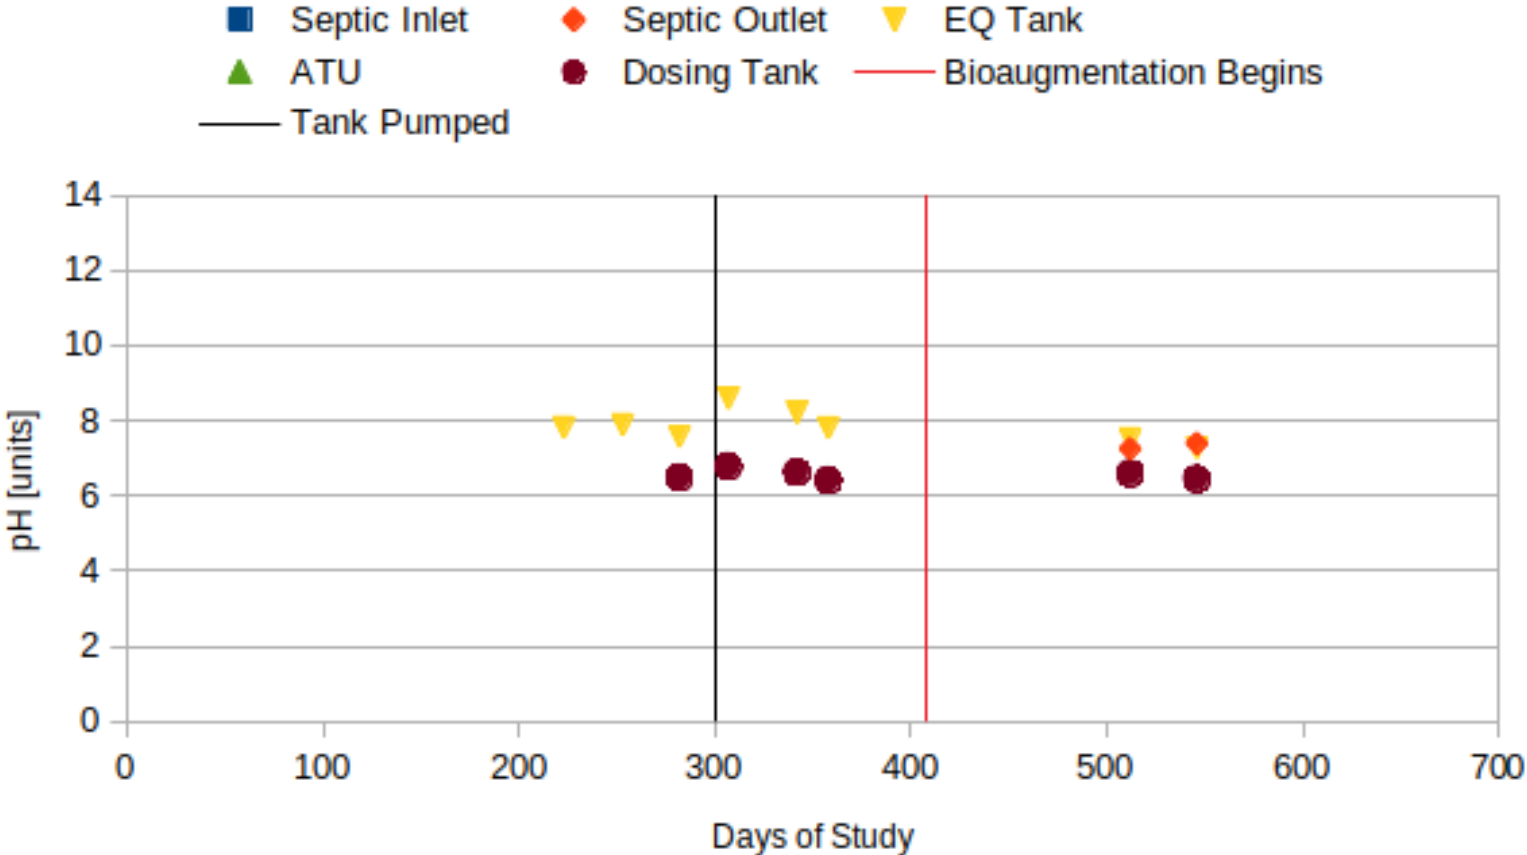
Goose Creek: Results – pH

pH is stable
